FAÇADE & ROOF ASSESSMENT REPORT

One on 4th

713 W 4th Avenue
Stillwater, OK 74074

Subject: Building Envelope Assessment Draft Report
One on 4th
713 W 4th Avenue
Stillwater, OK 74074
Partner Project No. 22-362181.3

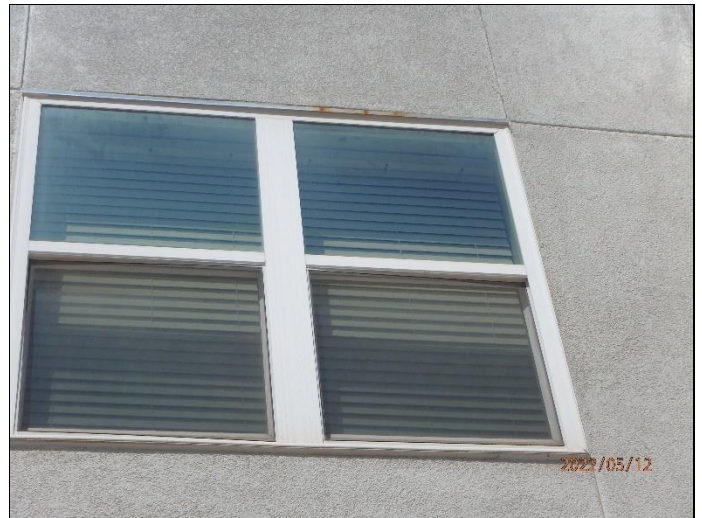
At 8 window heads, Partner identified corrosion deteriorated J-Track weep track. At these locations, Partner recommends removing a minimum of 12" tall full length of window head and down jamb for removal of the J-track and lath. Reinstall J-track, weep track, flashing, lath and stucco. Blend stucco in and coat with elastomeric coating (control joint to control joint). An opinion of cost for this work is included in Cost Tables below

16. Corrosion at window head

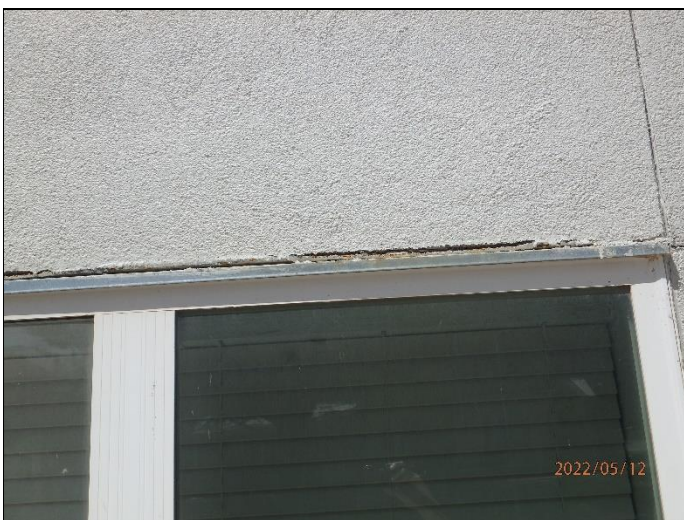
17. Corrosion at window head

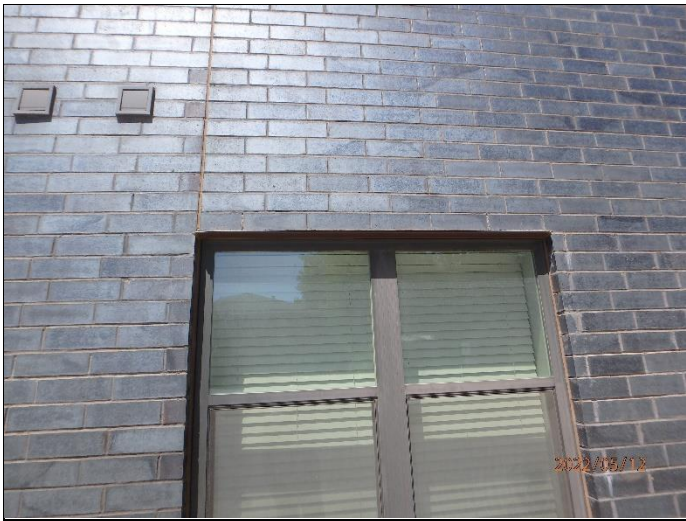
The face brick installation generally appears to be in good condition. At multiple locations weep vents are not installed at base of the wall, window heads and over doors. The head joint requires cleanout at these locations and insertion of a weep vent.

19. Head of window – missing weep vents

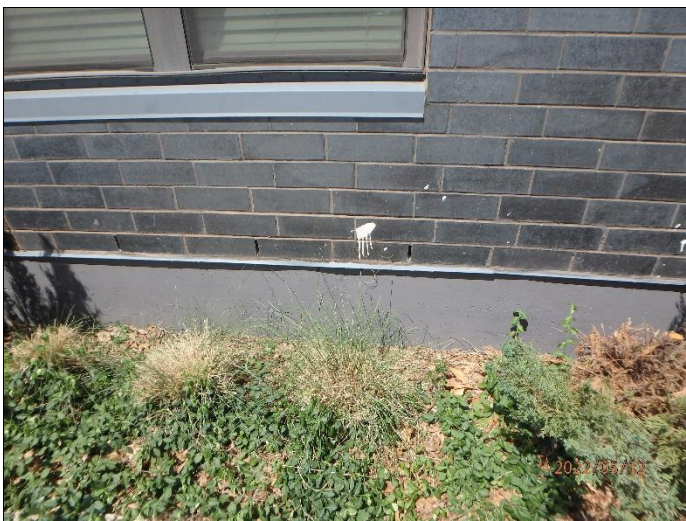
21. Base of face brick – missing weep vents

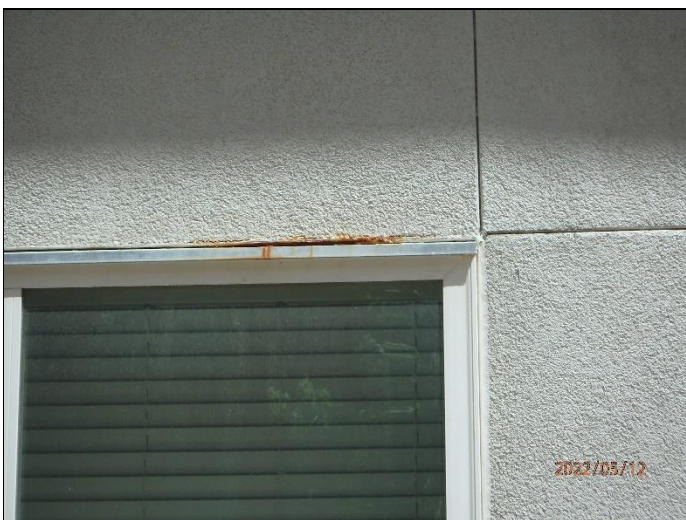
23. Corrosion at window head

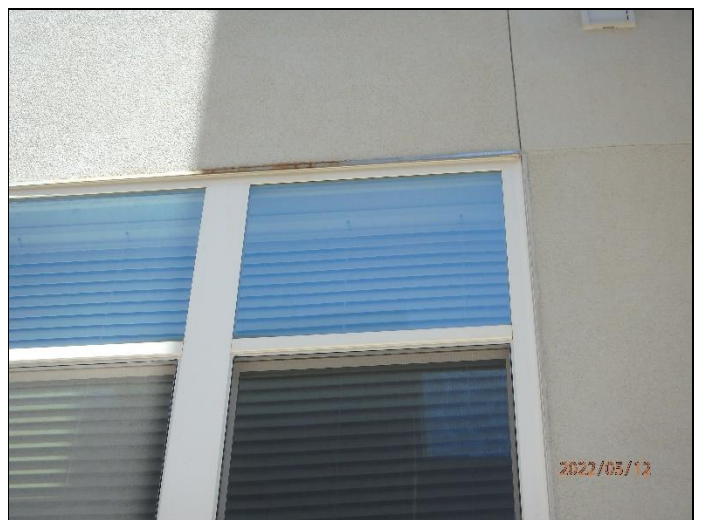
24. Corrosion at window head

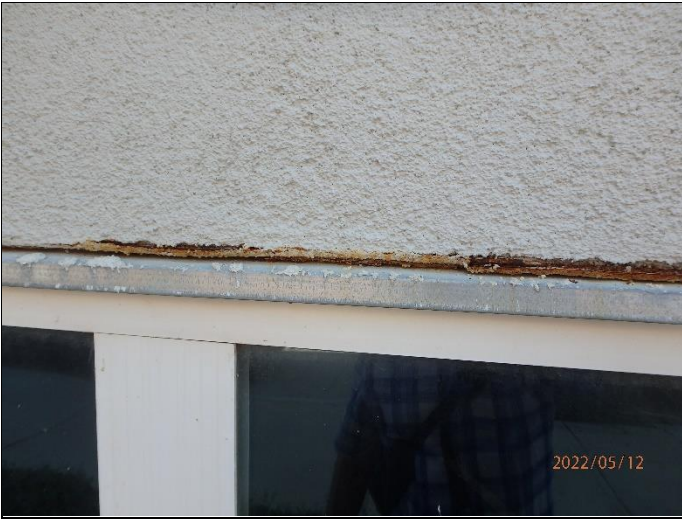
25. Corrosion at window head

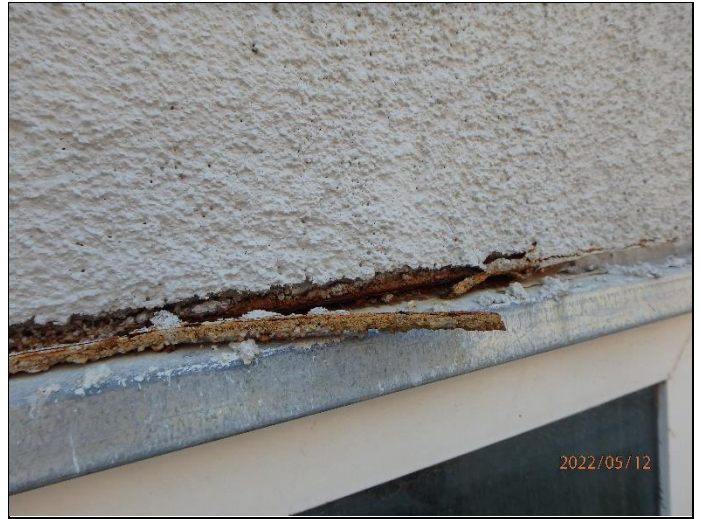
26. Corrosion at window head

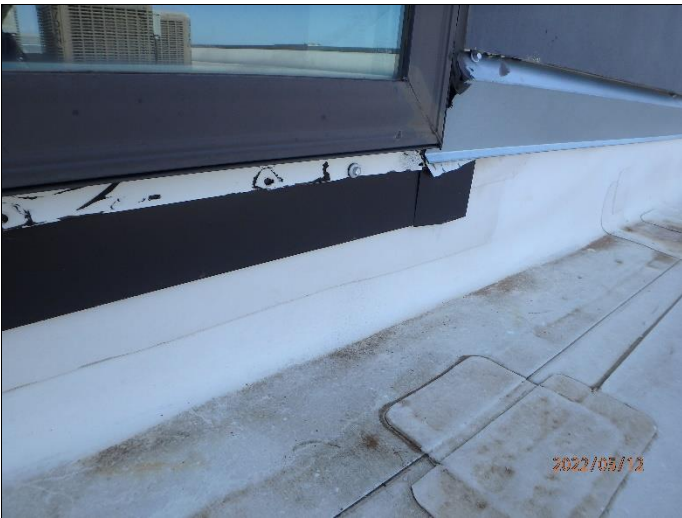
33. Missing counterflashing – Courtyard 1 roof

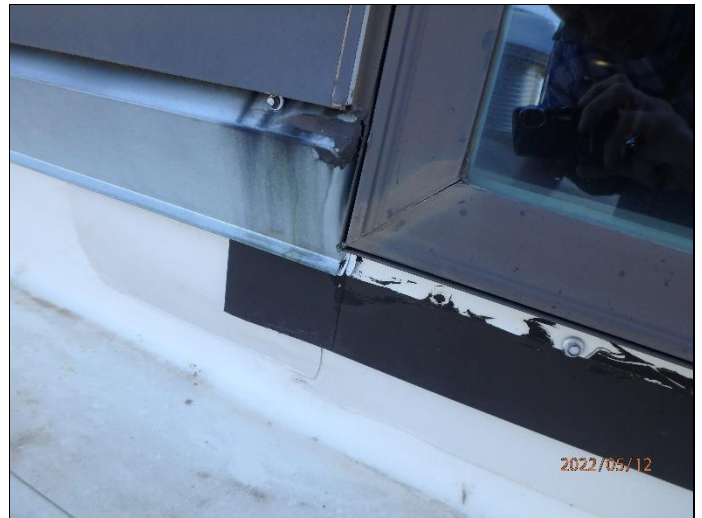
34. Missing counterflashing – Courtyard 1 roof

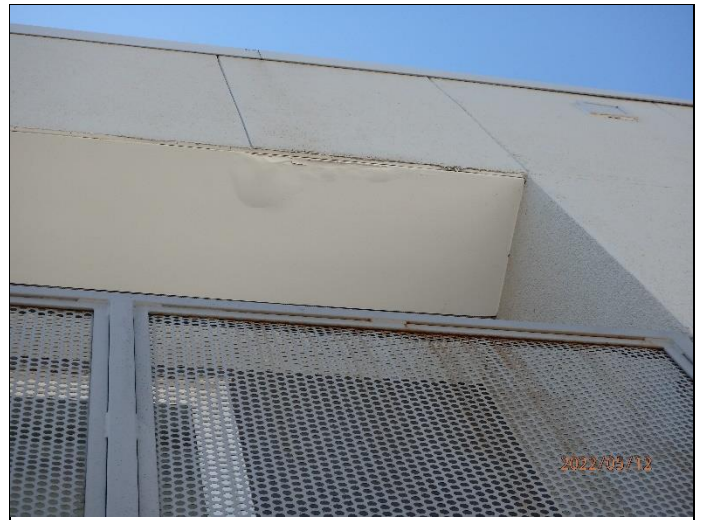
57. No drip at soffit

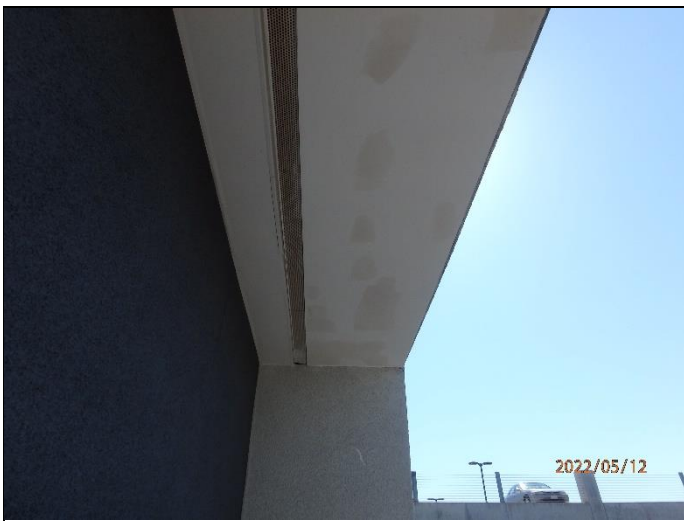
Several areas of deteriorated soffits were observed on the north side and northeast corner of the building. The soffit appears to be constructed out of gypsum board. One area of soffit appeared to consist of a cementitious finish system applied to gypsum wall board. Partner recommends removing and replacing

58. 5th floor soffit deterioration

the damaged soffit finish, during reinstall a drip edge is required to prevent wicking of water to the gypsum board soffit material. An opinion of cost for this work is included in Cost Tables below.

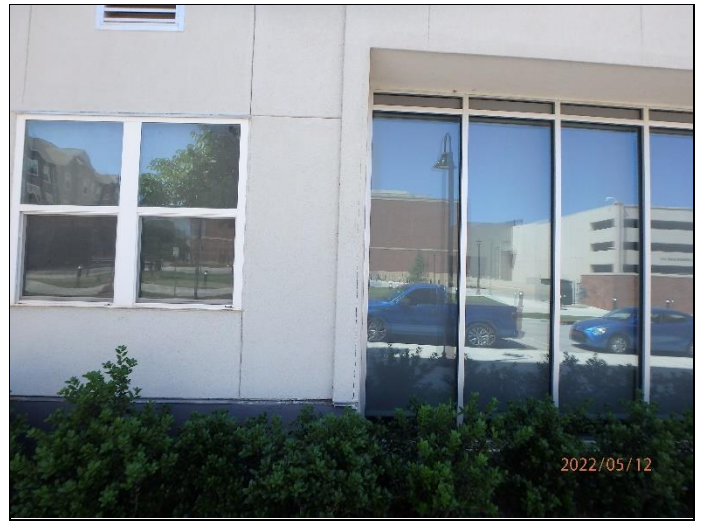
The stucco system appears to generally in good condition. Partner did observe two linear crack locations that appear to be from building movement. One location at the North end of the building adjacent to the Office storefront and the other at the intersection of the parking garage and the south wall (Courtyard 1). These cracks require removal of the stucco, repair weather barrier, blend stucco in and coat with elastomeric coating (control joint to control joint). An opinion of cost for this work is included in Cost Tables below

79. Crack at edge - stucco

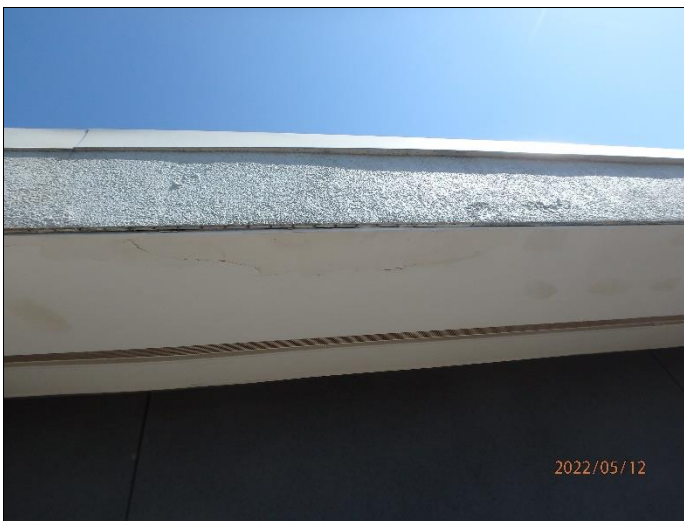
80. Crack at edge - stucco

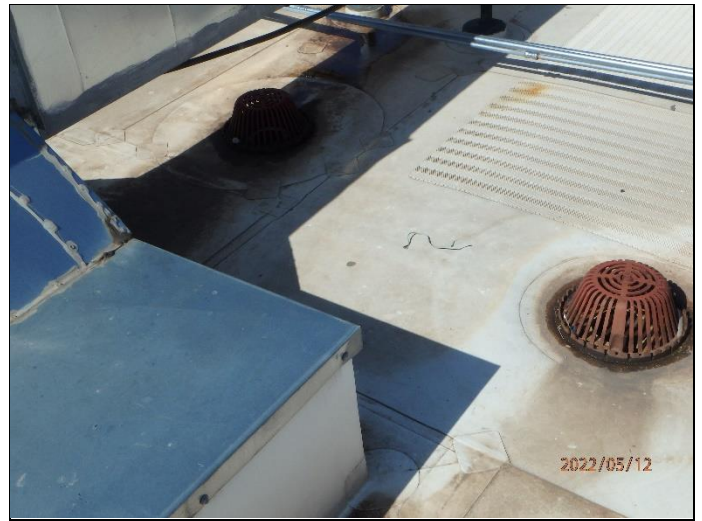
103. Primary and secondary drain – secondary drain is too high for drainage

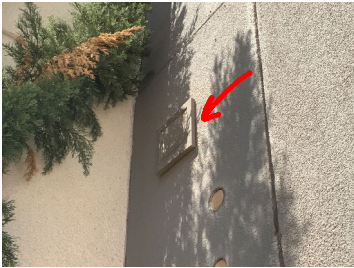
Isolated dryer vent, no sealant. Others are sealed.

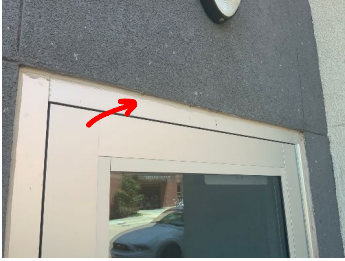
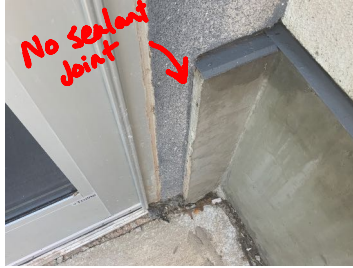
Corridor entry - sealant missing near door
- no door head flashing.

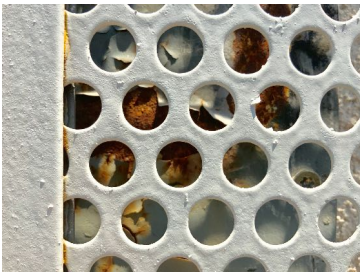
Guardrail plates rusted

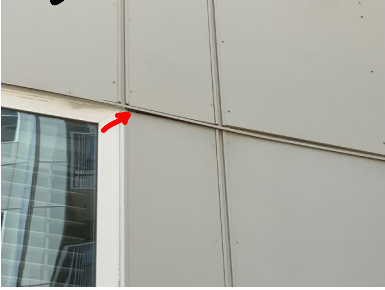
Large opening at top of panel

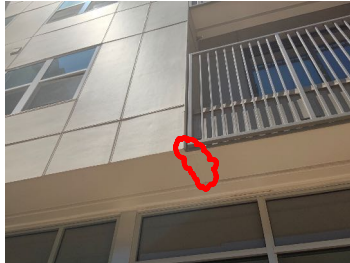
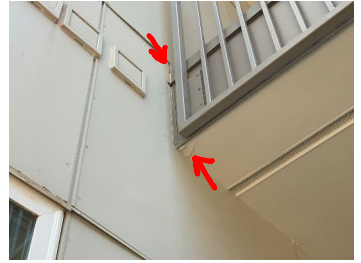
Damaged soffit below 2nd floor balconies, several locations

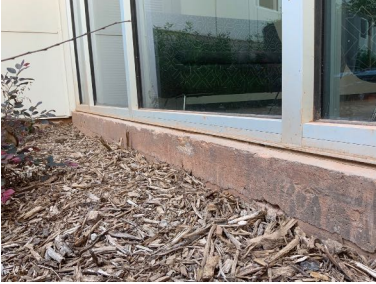
No storefront pan flashing over slab edge.

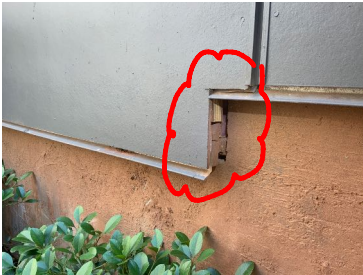
Unsealed openings at foundation drops

- All similar areas should be reviewed

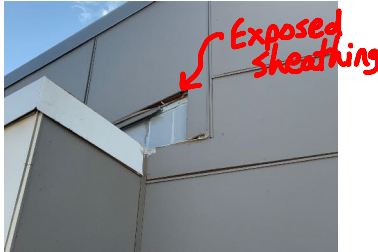
Standing at 471, There are no counter flashings over term bars

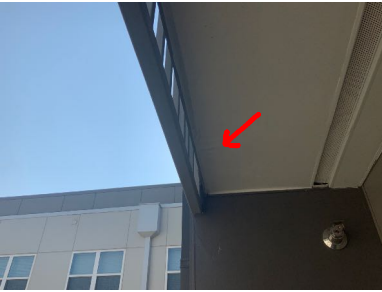
Unit 444- soffit damage. Return is sealed

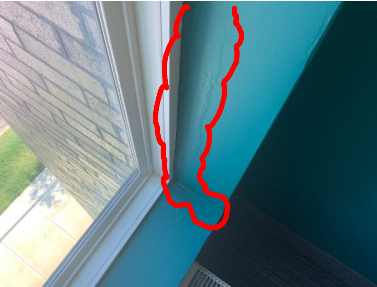
Stains/peeling paint at corridor window near Unit 459

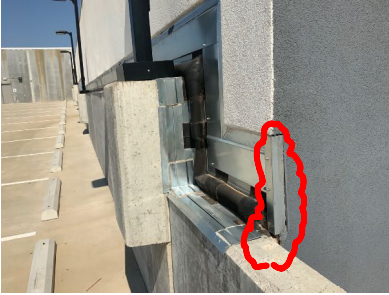
At other end of E.J. there are unsealed conditions where the ExpandoFlash meets the stucco and vertical Emseal.

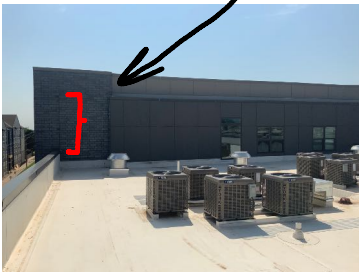
Masonry F.J. does not continue to top of wall
