PHASE I ENVIRONMENTAL SITE ASSESSMENT REPORT

Ascend South Creek

3060 Southcreek Boulevard
Orlando, Florida 32824

Report Date: July 29, 2022
Partner Project No. 22-378483.1

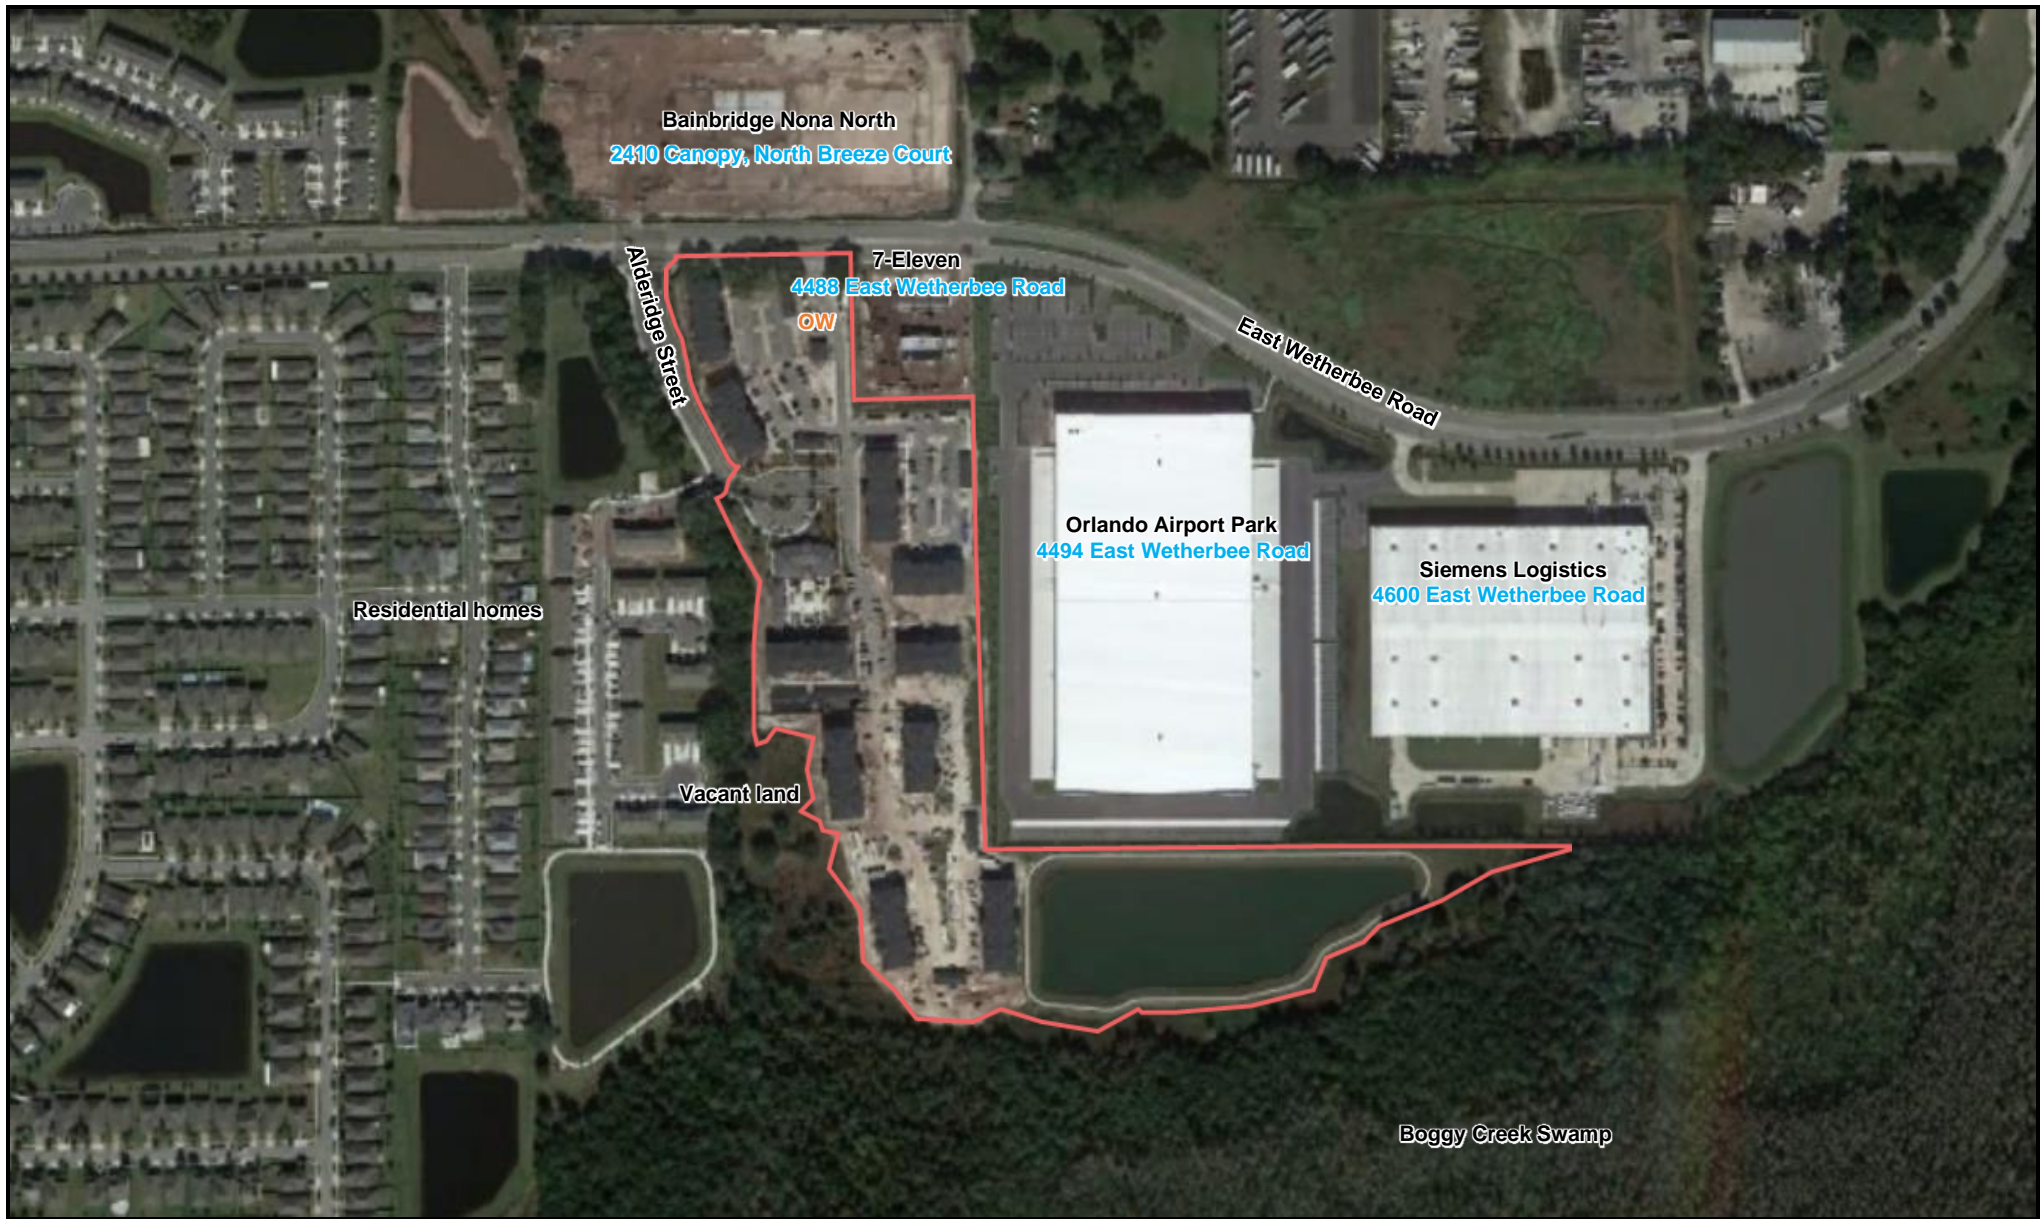
FIGURE 2: SITE PLAN
Project No. 22-378483.1

**GROUNDWATER
FLOW**

Oil/Water Separator **OW**

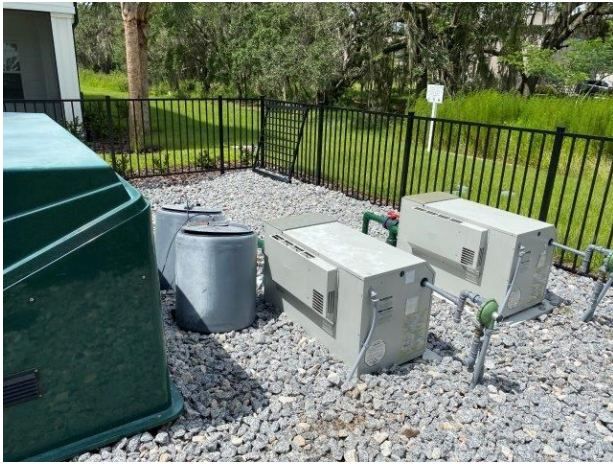
9. Pool heater connected to propane UST

UST No. 1
Piping Secondary Containment:	Unknown
Type of Corrosion Protection:	Unknown
Type of Leaking Detection Equipment:	Unknown
Type of Overfill Protection:	Unknown
Evidence of Leaks, Stains, or Spills:	No
Reported Release(s):	No
Compliance with UST Regulations:	Yes

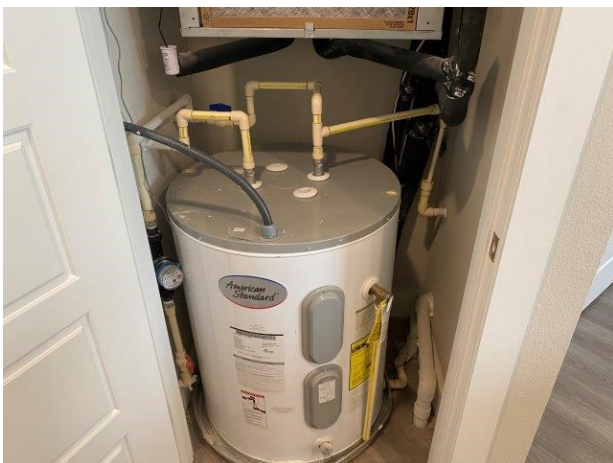
17. Typical apartment electric water heater

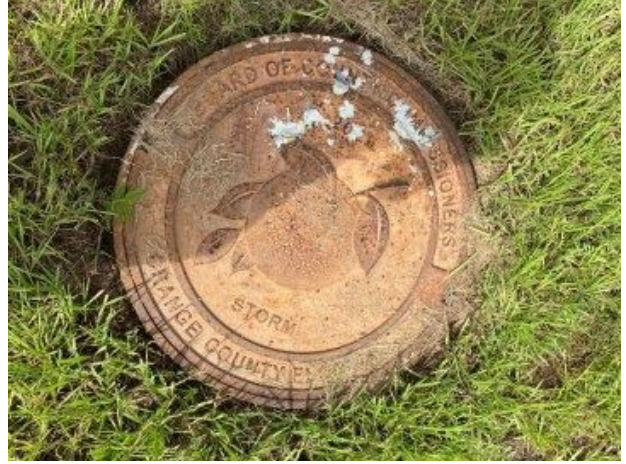
20. Subject property storm drain

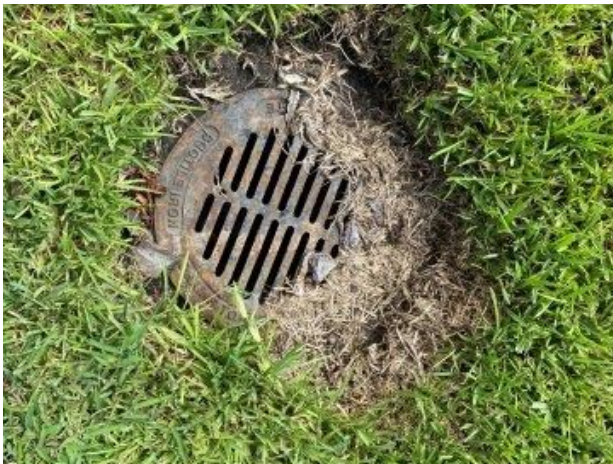
21. Subject property storm drain

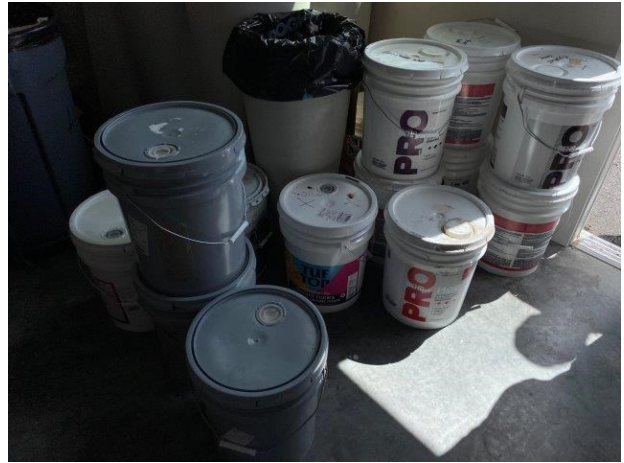
26. Stored paint and chemicals in maintenance building

No evidence of the use of reportable quantities of hazardous substances was observed on the subject property. Small quantities of paint, general maintenance supplies, and pool maintenance supplies were found to be properly labeled and stored at the time of the assessment with no signs of leaks, stains, or spills. The storage and use of maintenance supplies does not appear to pose a significant threat to the environmental integrity of the subject property at this time.

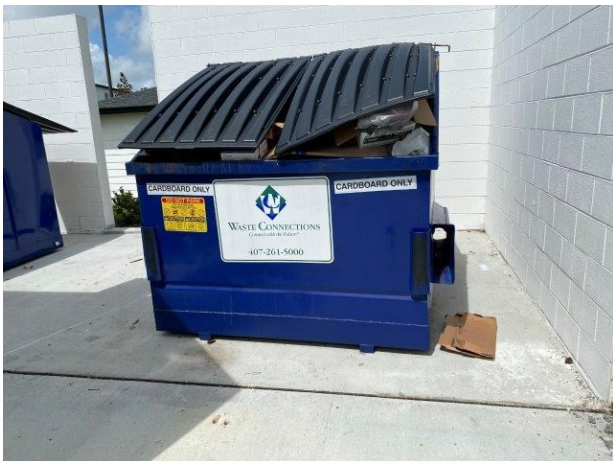
29. Subject property commercial recycling and dumpster area

Solid waste generated at the subject property is disposed of in commercial dumpsters located northeast on the subject property. An independent solid waste disposal contractor, Waste Connections, removes solid waste from the subject property. No evidence of illegal dumping of solid waste was observed during the Partner site reconnaissance.

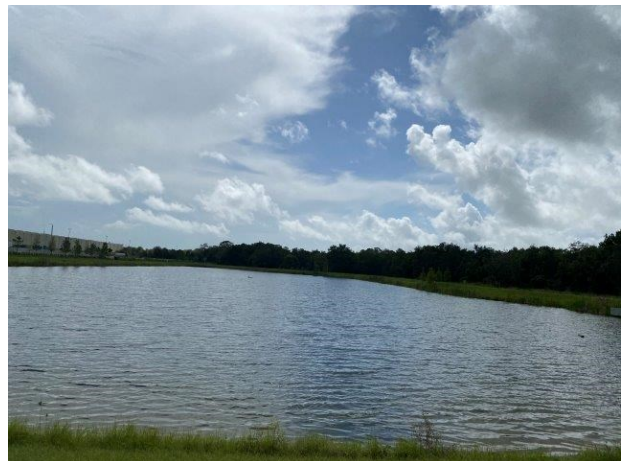
30. Subject property retention pond

The nearest surface water to the subject property is a canal located approximately 20 feet and geographical west of the subject property. With the exception of a retention pond towards the southeast on the subject property, no other surface water bodies or features were observed.
