FAÇADE & ROOF ASSESSMENT REPORT

One on 4th

713 W 4th Avenue
Stillwater, OK 74074

Subject: Building Envelope Assessment Draft Report
One on 4th
713 W 4th Avenue
Stillwater, OK 74074
Partner Project No. 22-362181.3

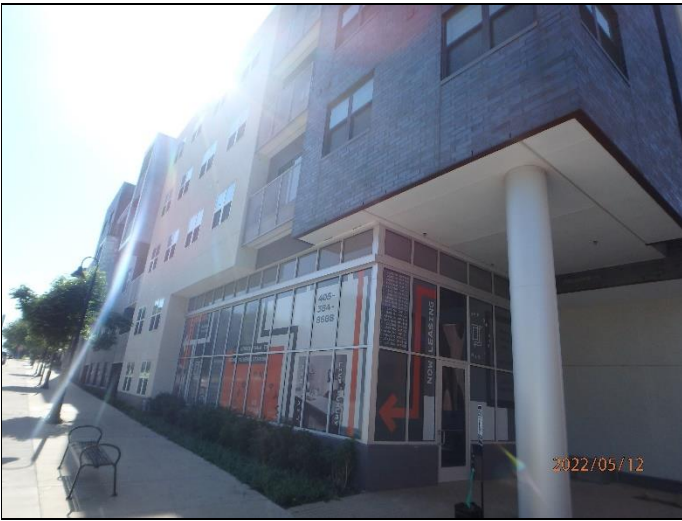
1. Partial view of North Elevation

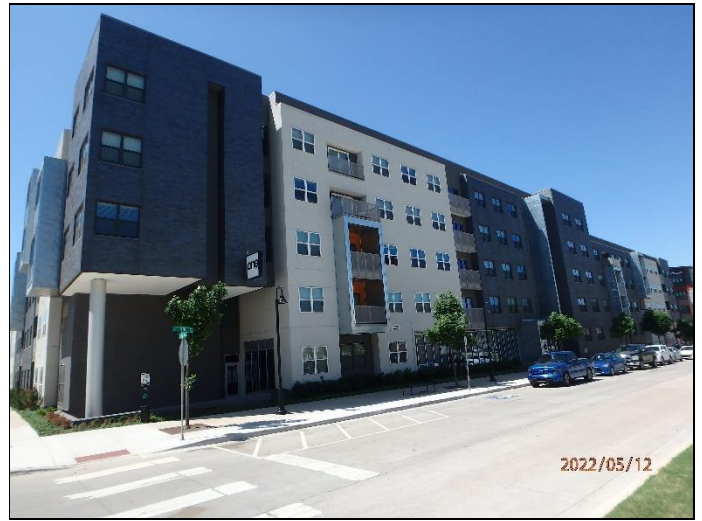
2. Overview of North Elevation

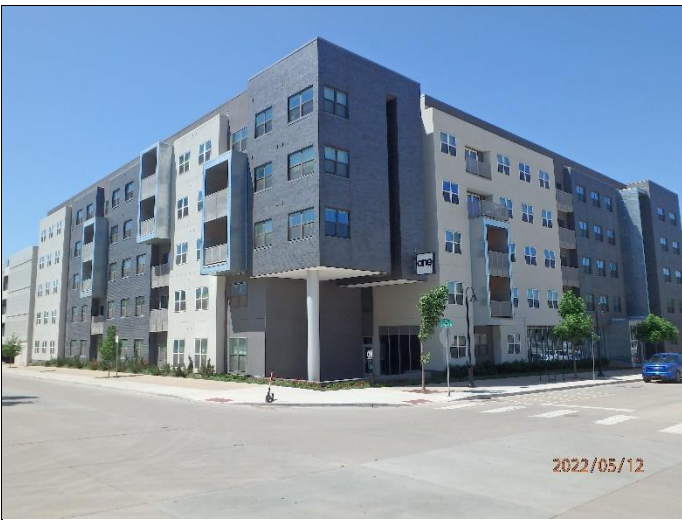
3. Overview of Northeast corner

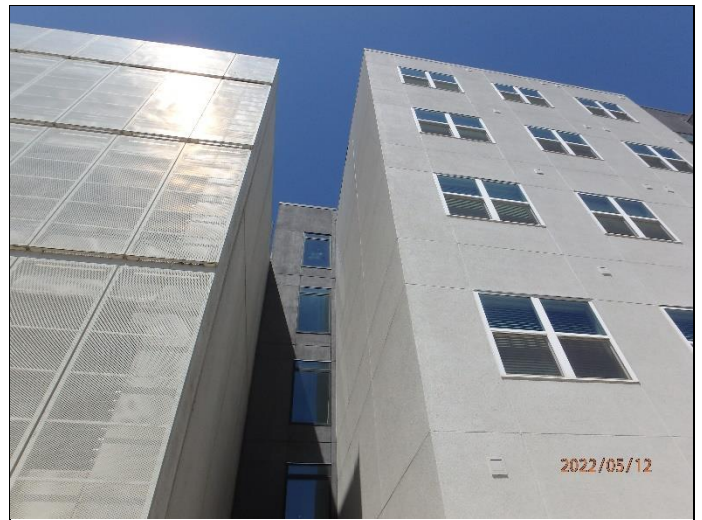
4. Partial elevation - East

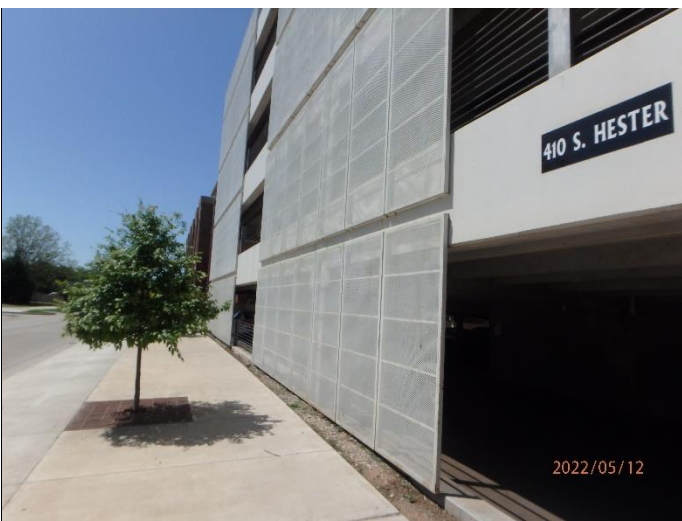
5. Partial parking garage - East

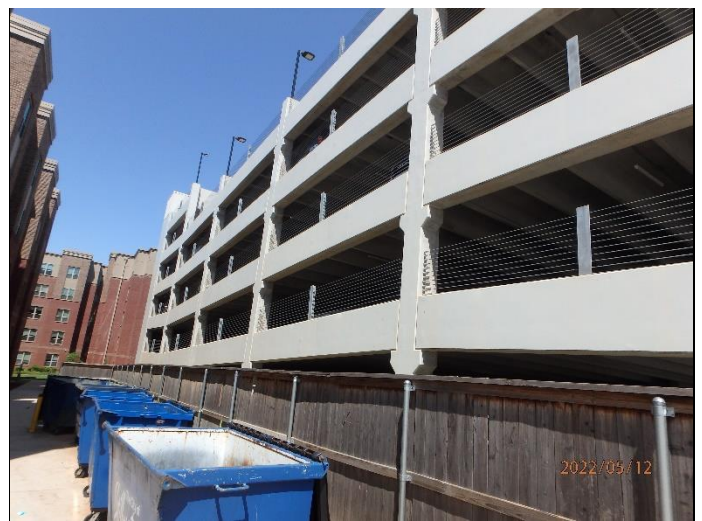
6. Parking garage - South

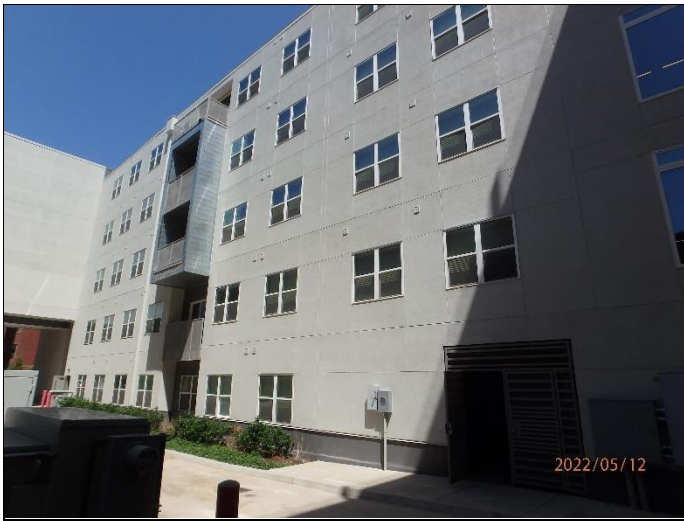
7. Overview of South Elevation

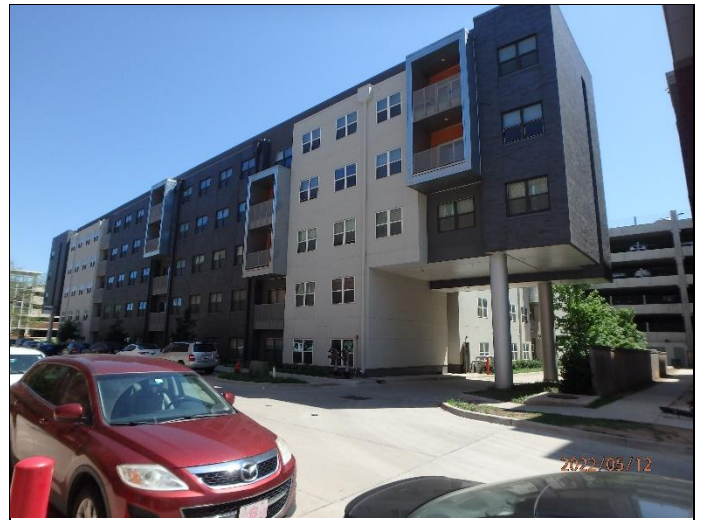
10. Overview of West elevation

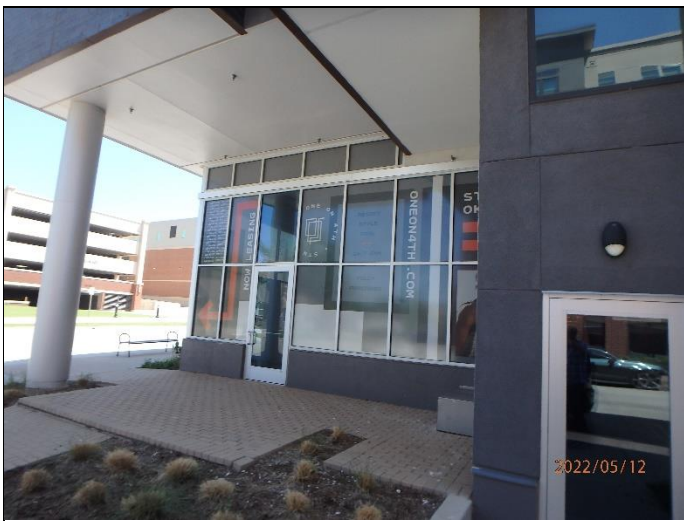
11. West entrance storefront

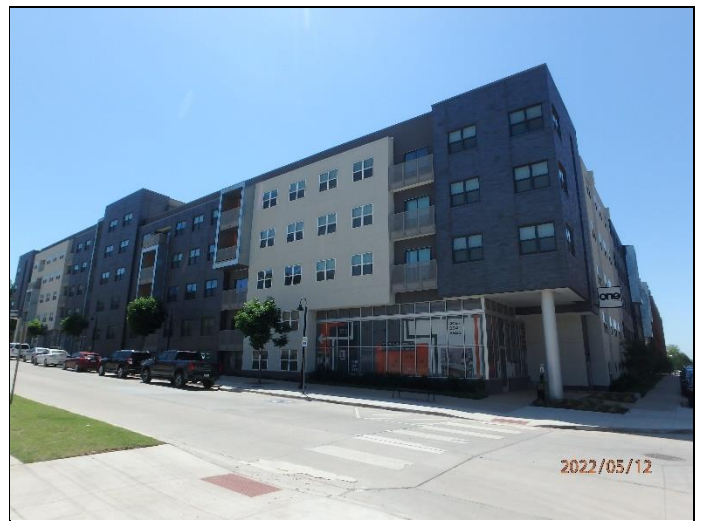
12. Overview of North elevation

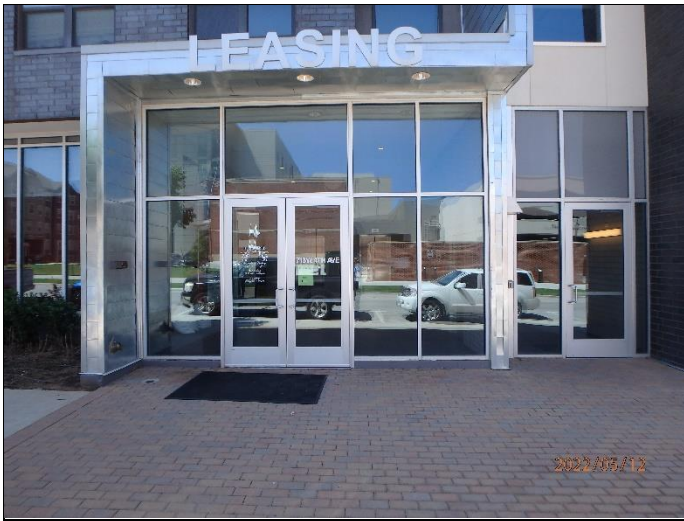
13. Main entrance – Leasing office

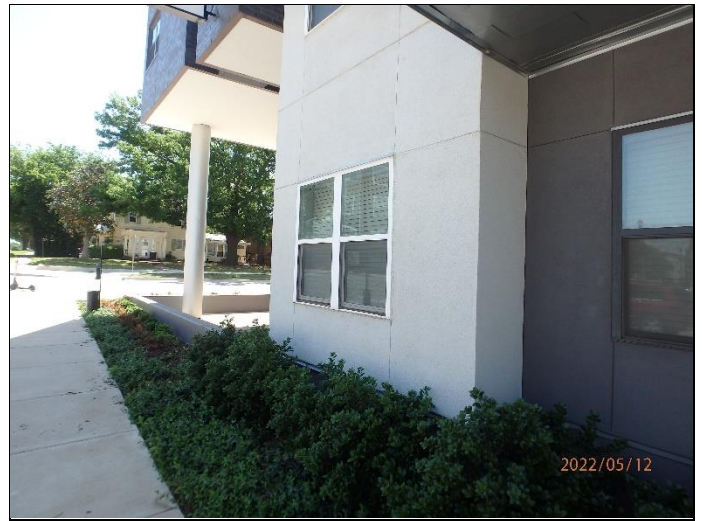
14. Overview of typical window

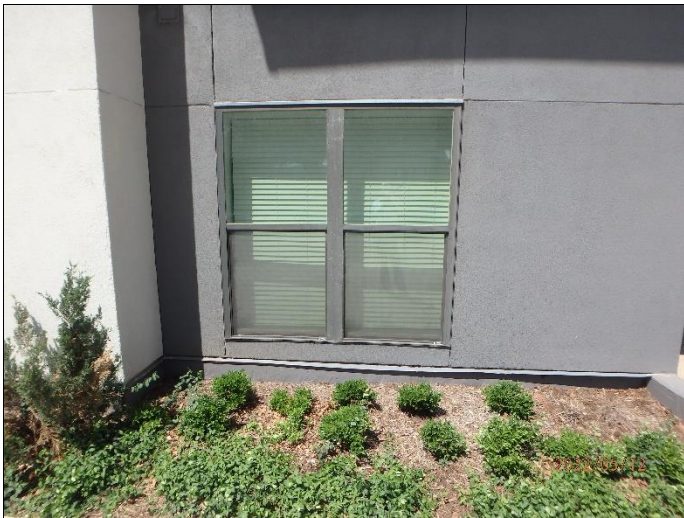
15. Typical window

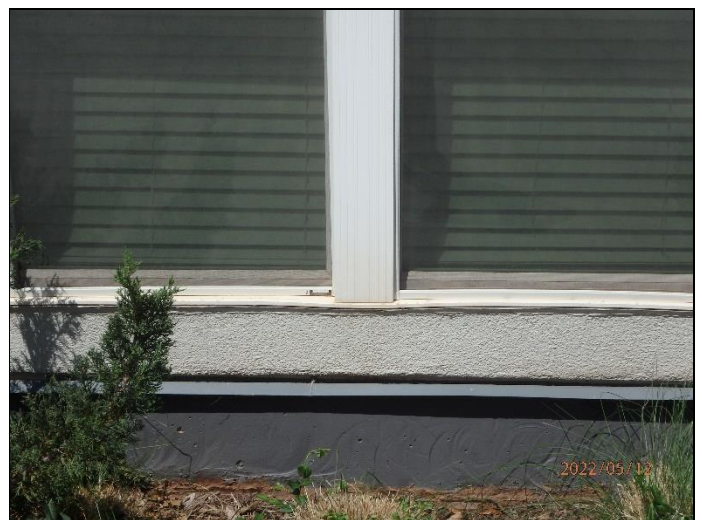
18. Window sill

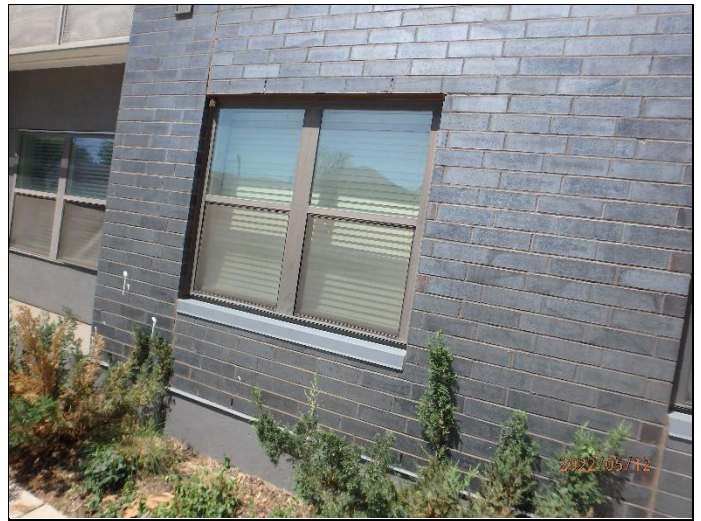
20. Typical window inset in face brick

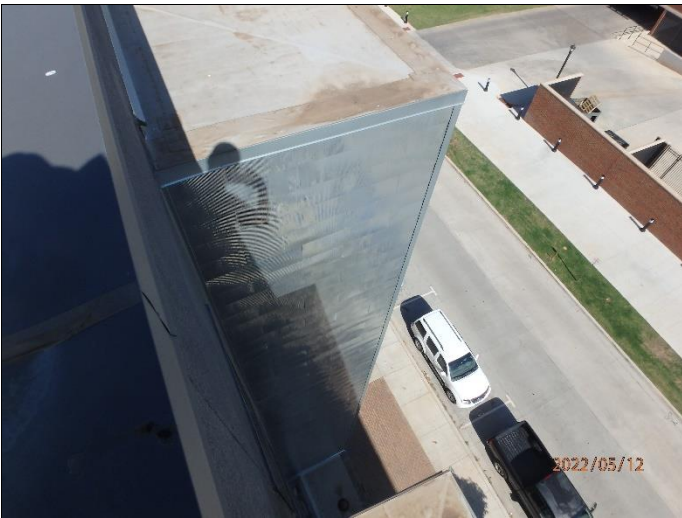
27. Metal panel elevation

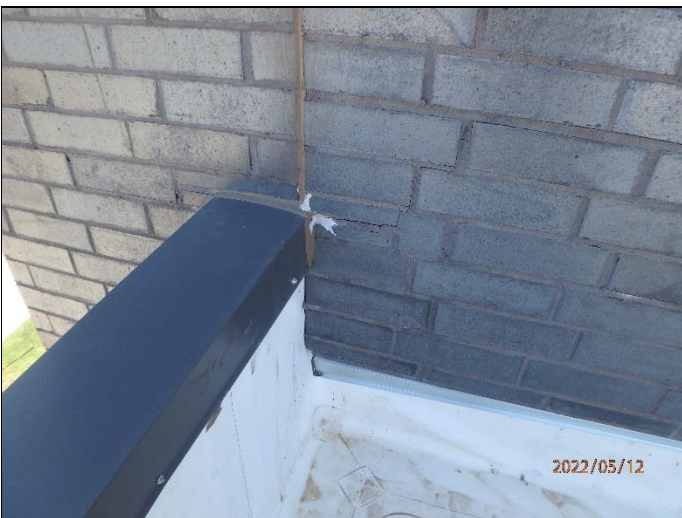
29. Brick to roof/parapet interface

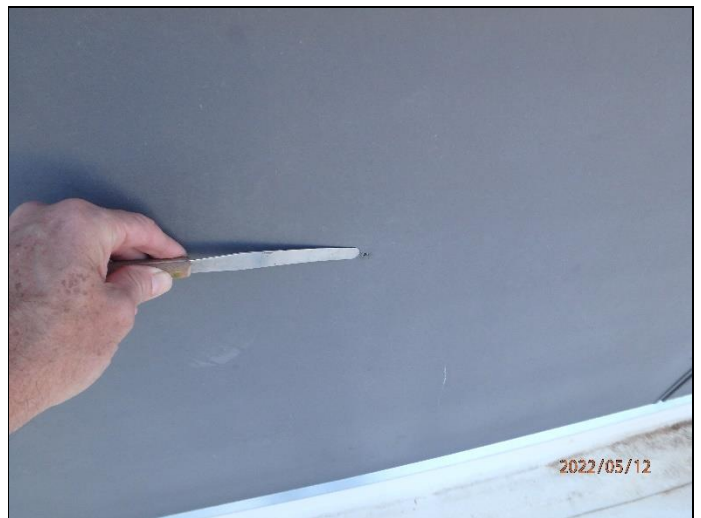
30. Overdriven fastener in fiber cement siding

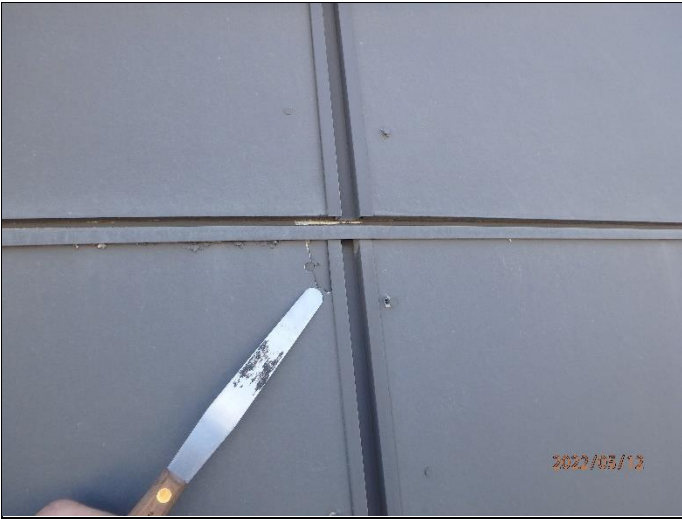
31. Overdriven fastener in fiber cement siding

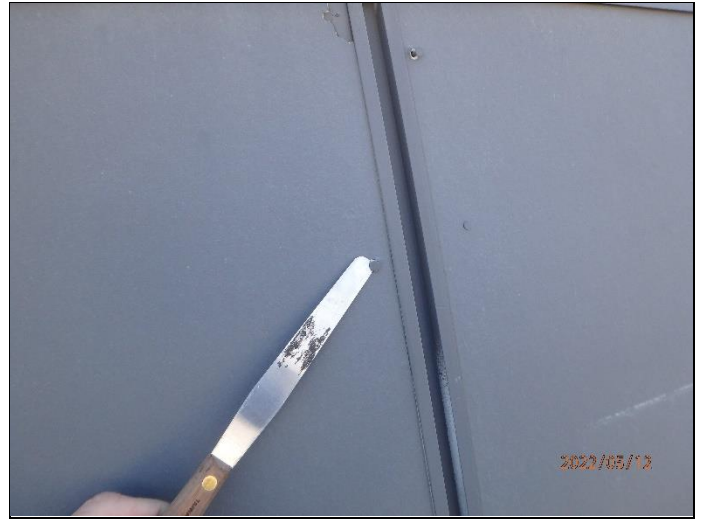
32. Overdriven fastener in fiber cement siding

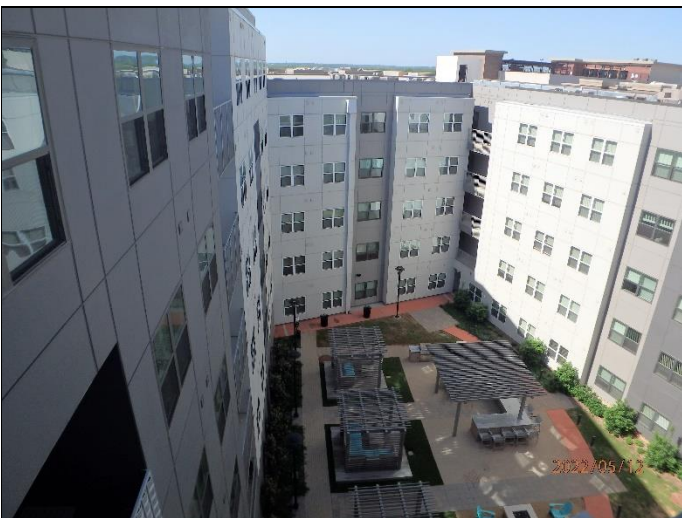
35. Courtyard 1 elevations

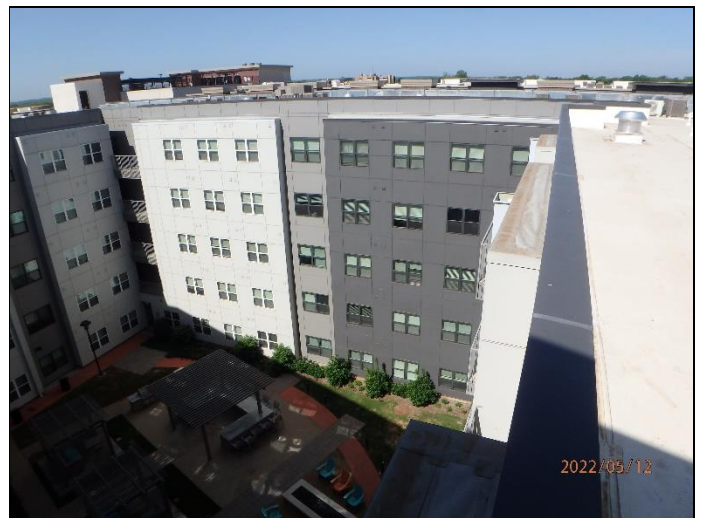
36. Courtyard 1 elevations

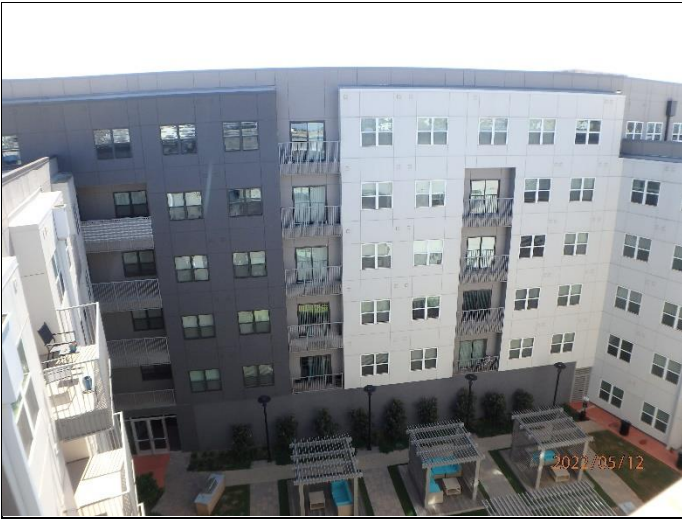
37. Courtyard 1 elevations

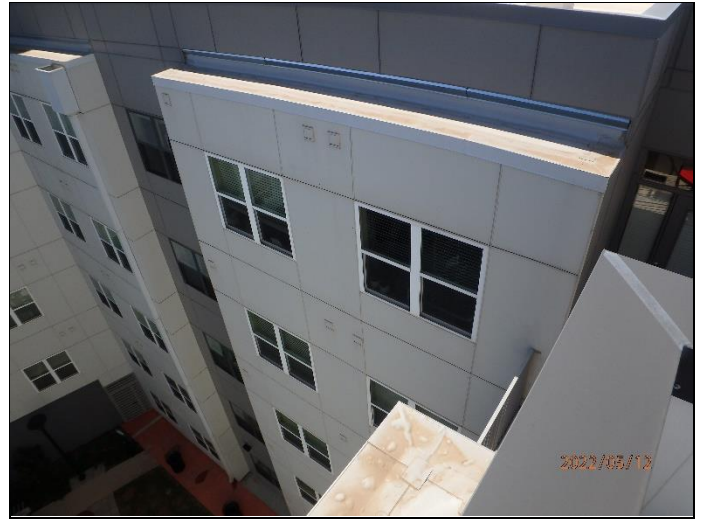
38. Courtyard 1 elevations

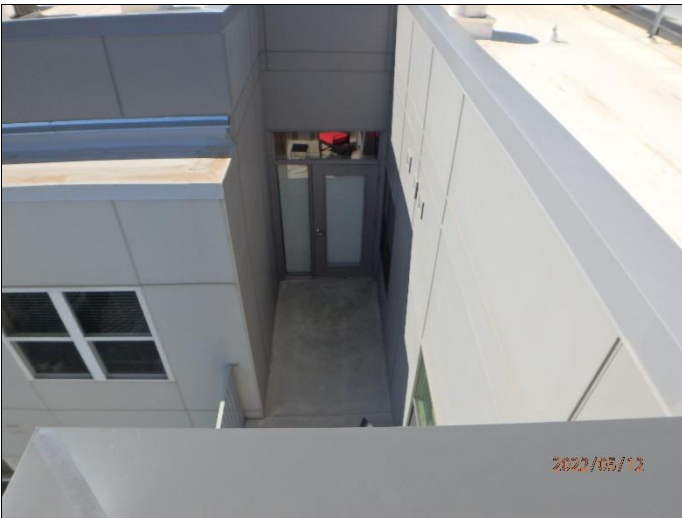
39. Unit balcony

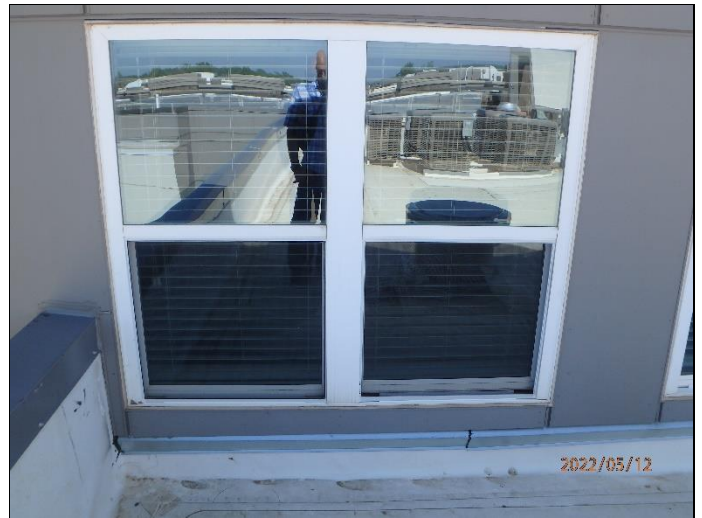
40. Window unit

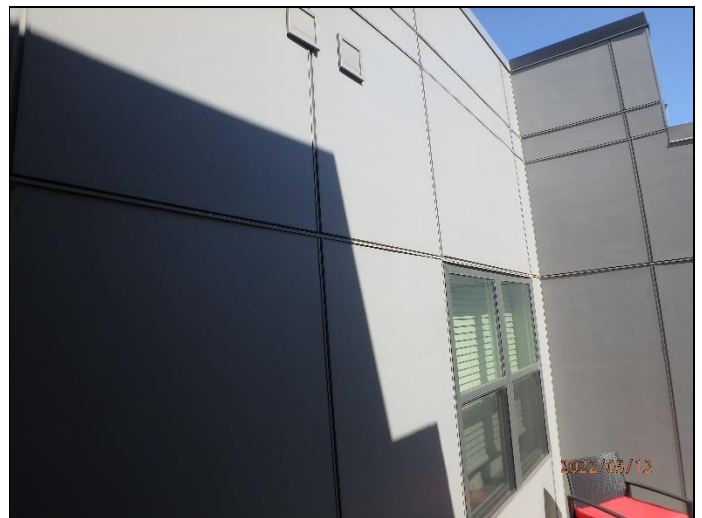
42. Balcony

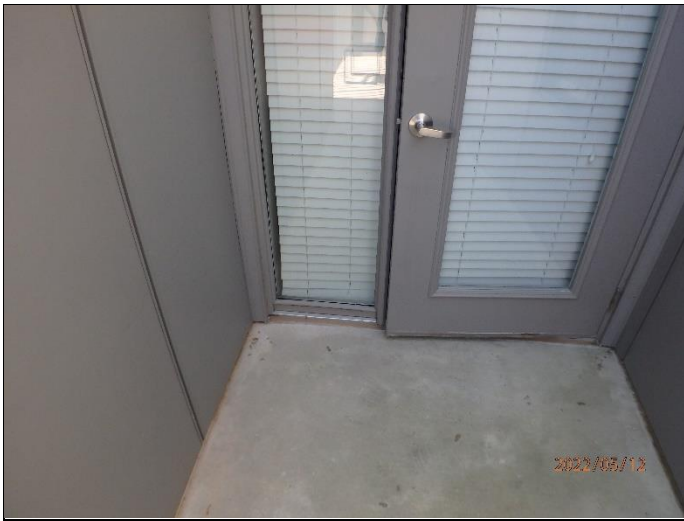
43. Access door to balcony

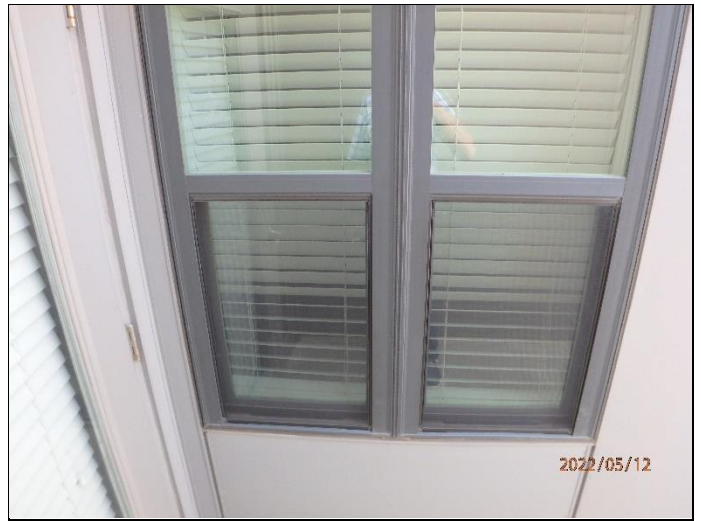
44. Unit window

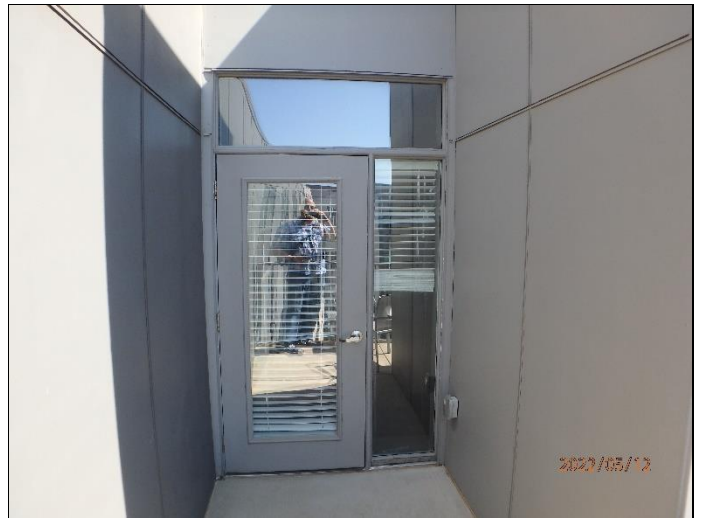
46. Balcony door

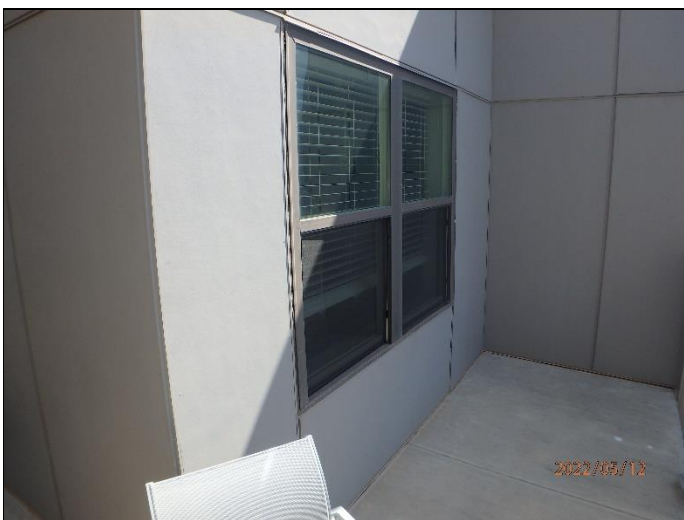
47. Unit window

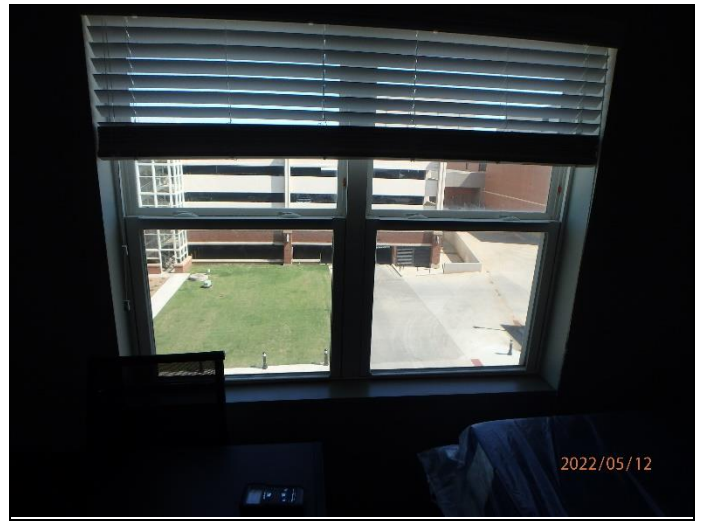
50. Unit window

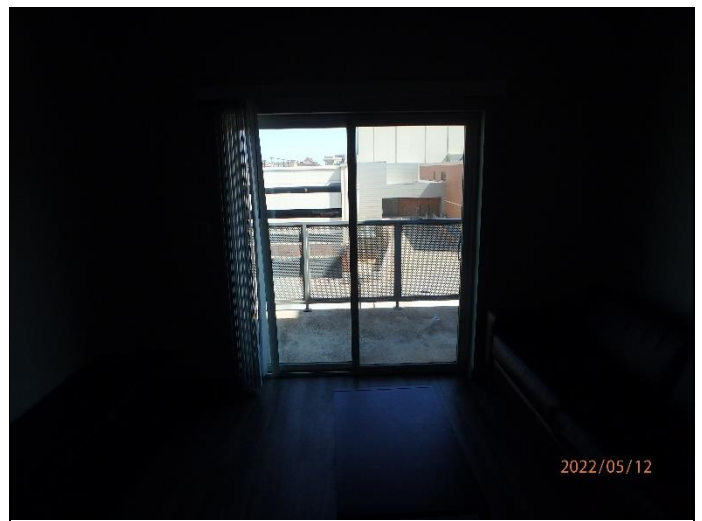
52. Unit sliding door

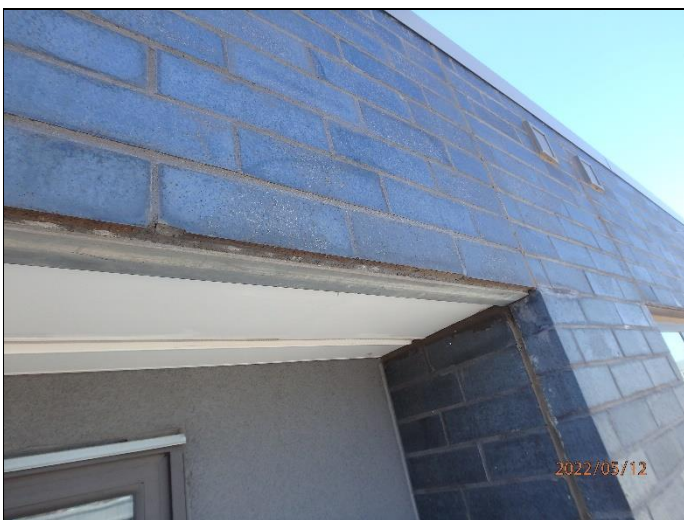
53. No weep vents above soffit, no drip

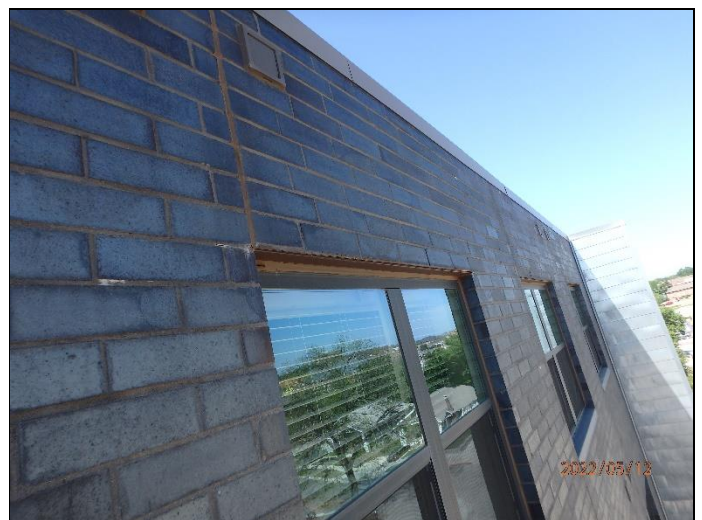
54. No weep vents above window

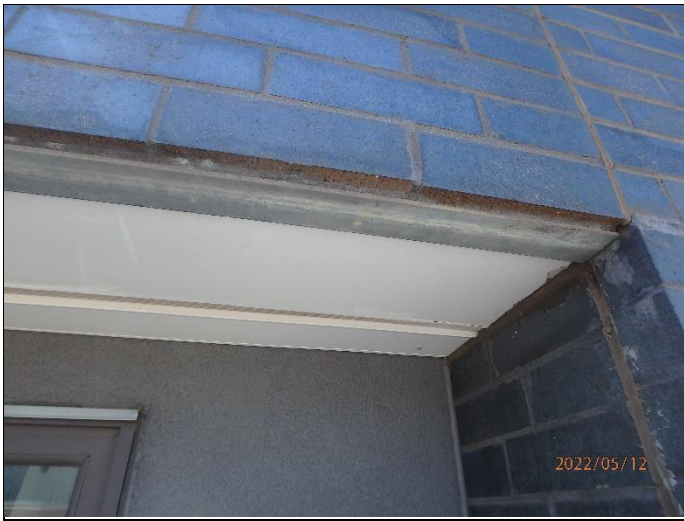
55. No weep vents above soffit, no drip

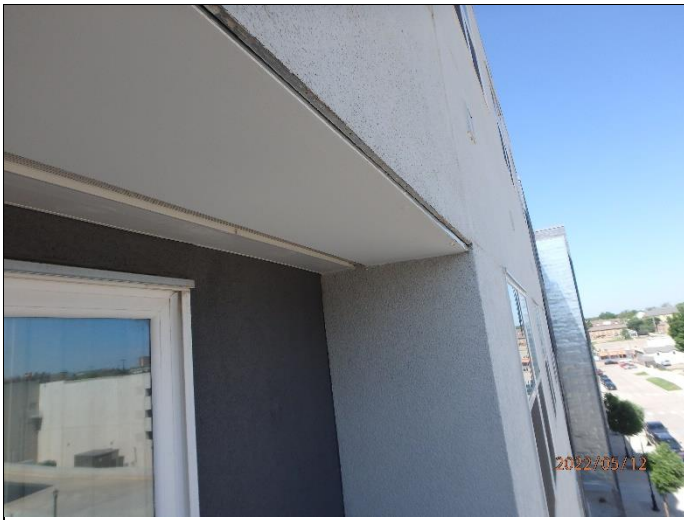
57. No drip at soffit

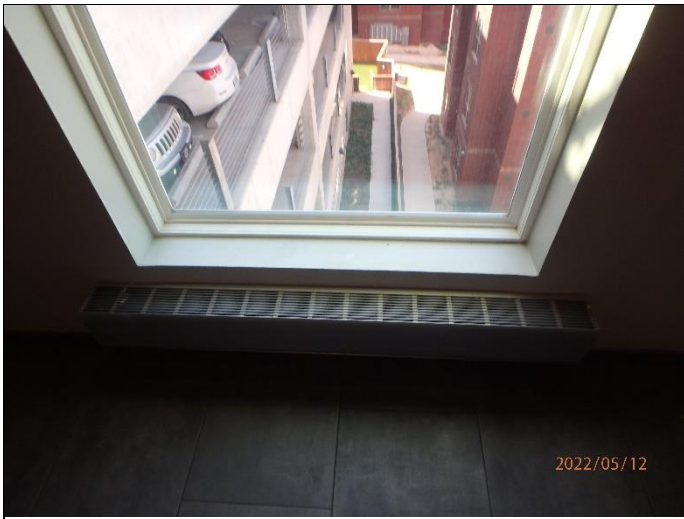
61. Common area window sill

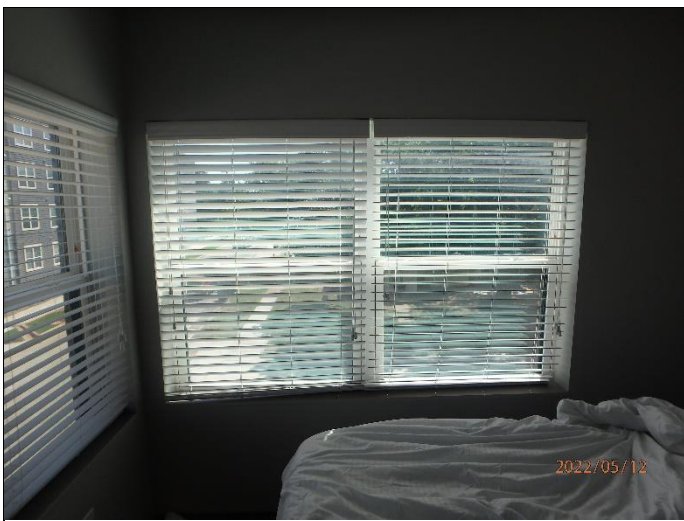
63. Unit window

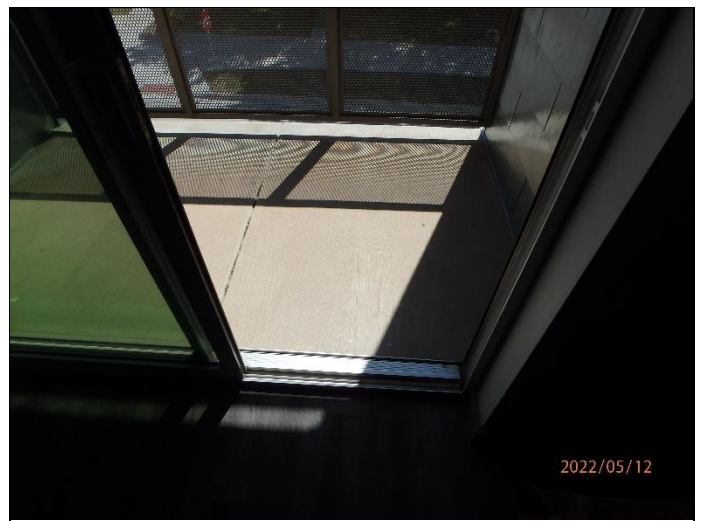
64. Unit sliding door

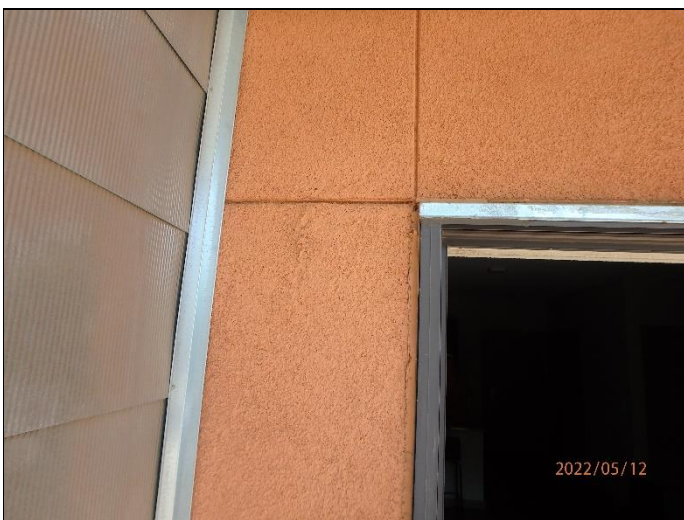
65. Stucco around sliding door

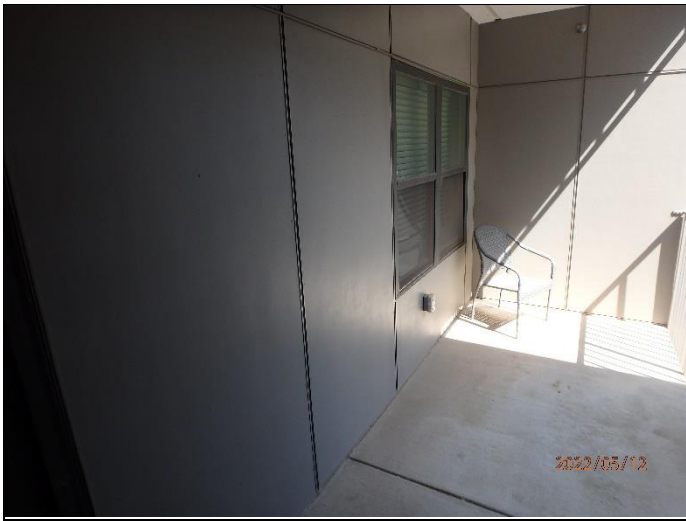
67. Unit balcony

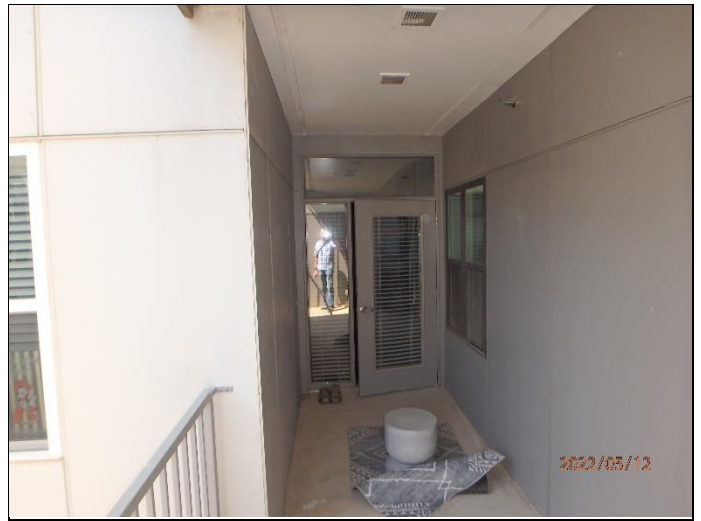
68. Balcony access door

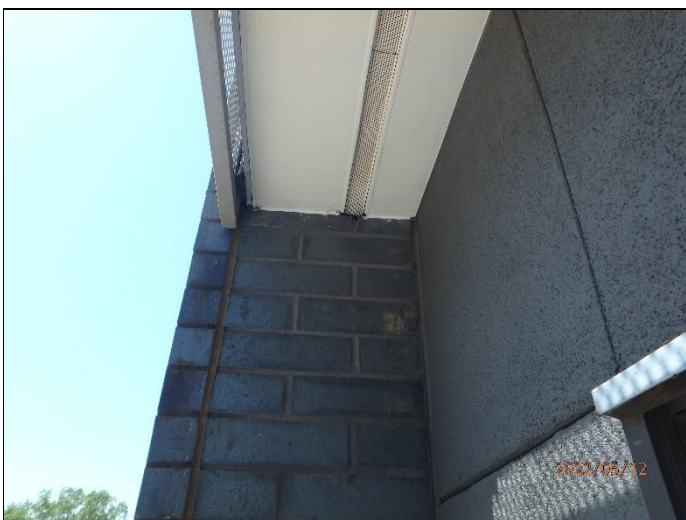
71. Balcony soffit

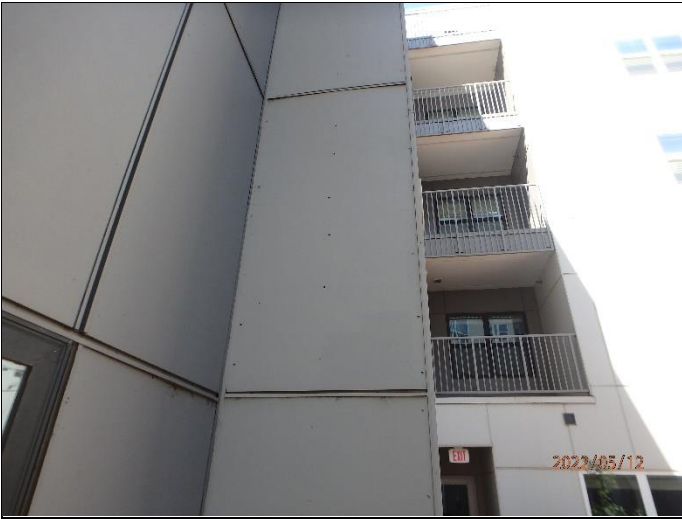
73. Overdriven fasteners in fiber cement siding

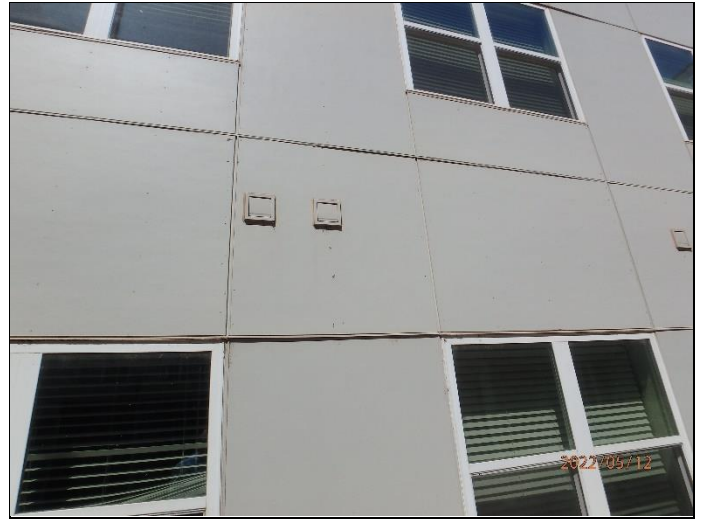
74. Overdriven fasteners in fiber cement siding

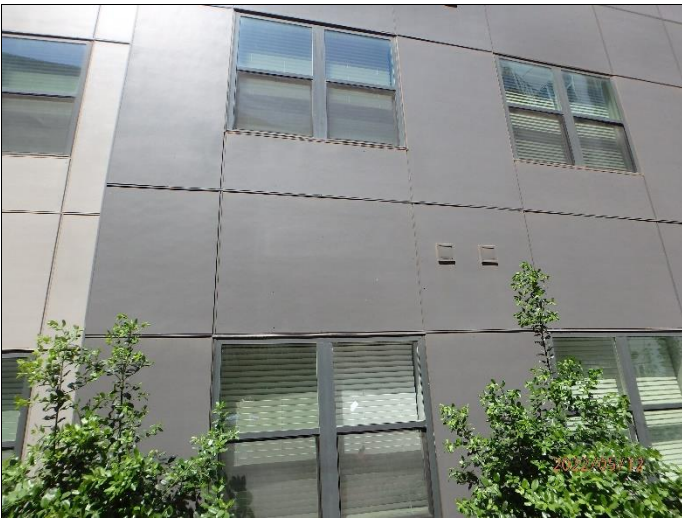
75. Overdriven fasteners in fiber cement siding

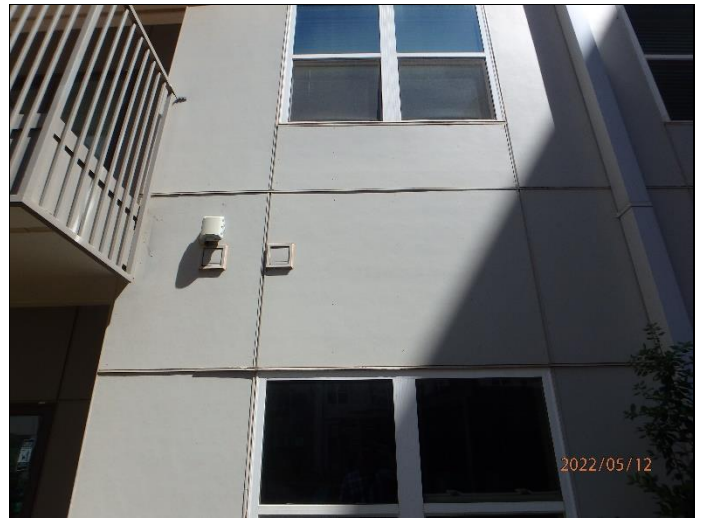
76. Overdriven fasteners in fiber cement siding

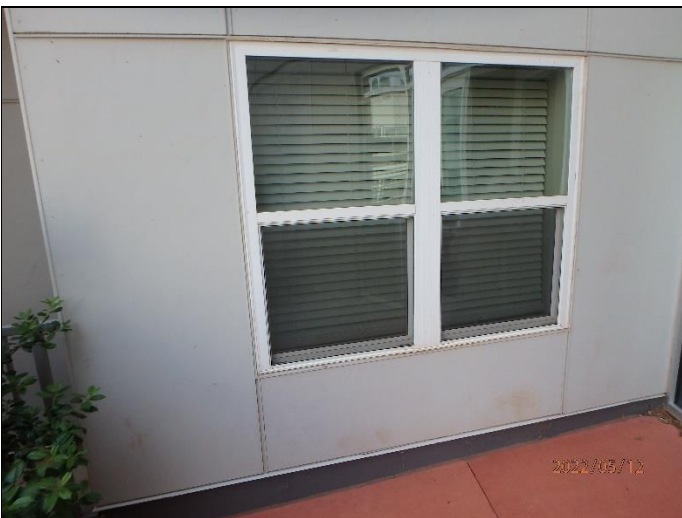
77. Overdriven fasteners in fiber cement siding

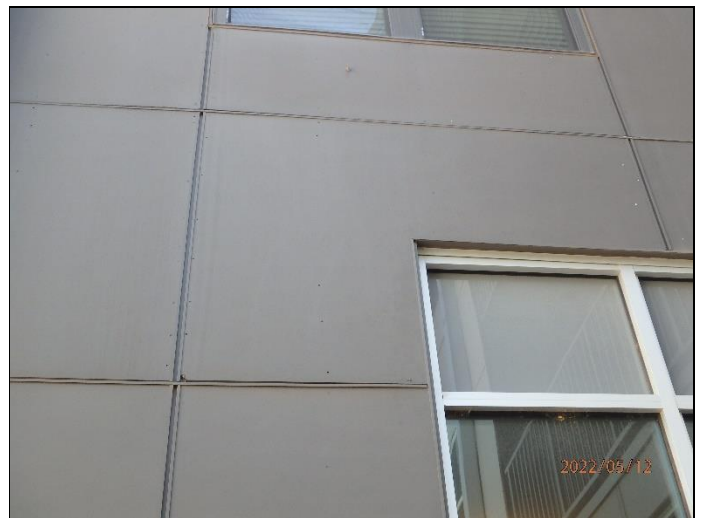
78. Overdriven fasteners in fiber cement siding
