FAÇADE & ROOF ASSESSMENT REPORT

One on 4th

713 W 4th Avenue
Stillwater, OK 74074

Subject: Building Envelope Assessment Draft Report
One on 4th
713 W 4th Avenue
Stillwater, OK 74074
Partner Project No. 22-362181.3

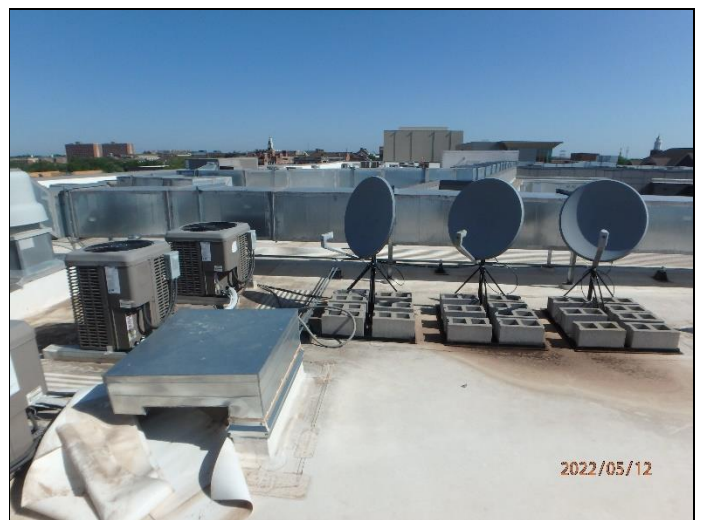
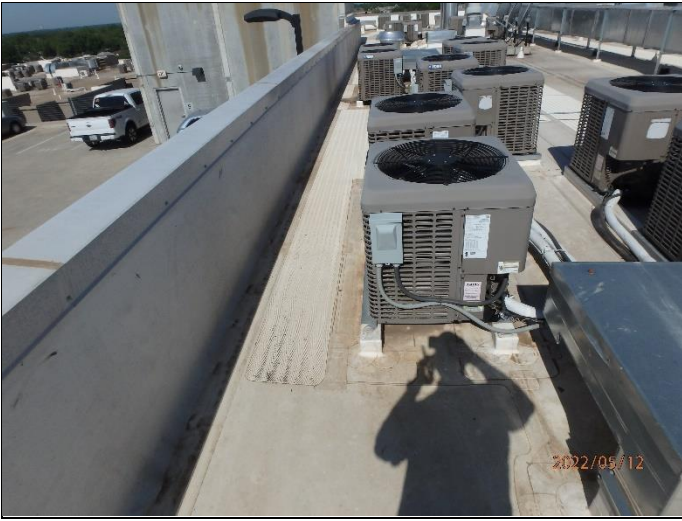
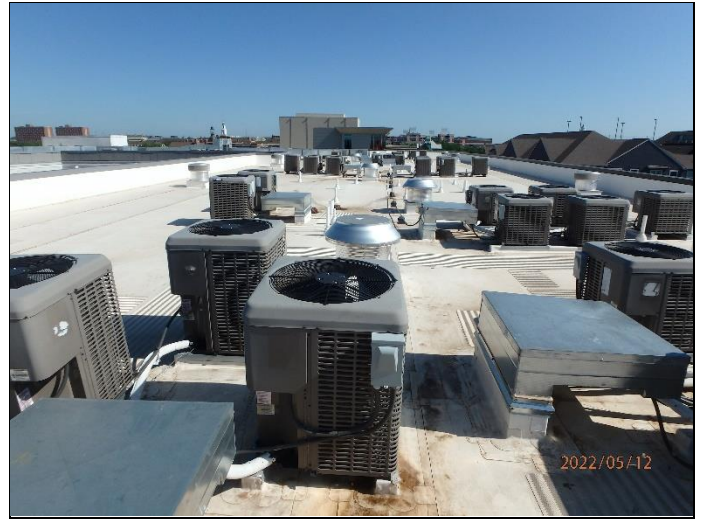
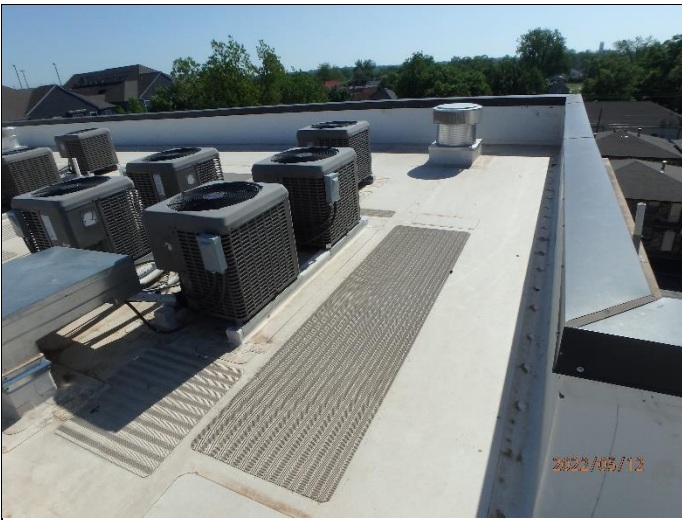
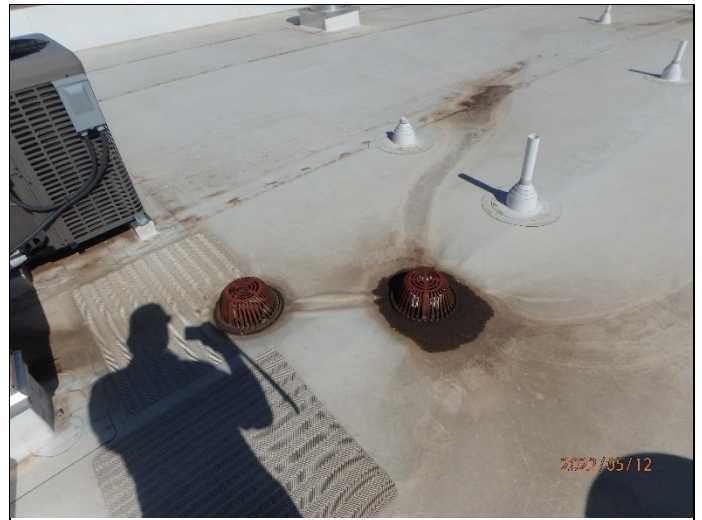
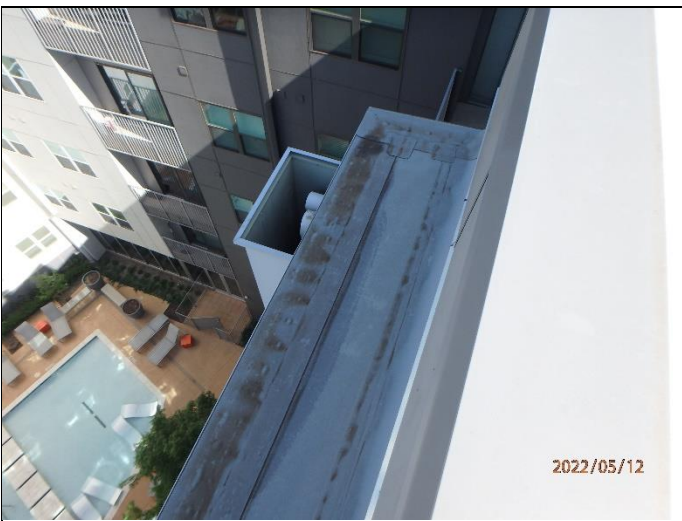
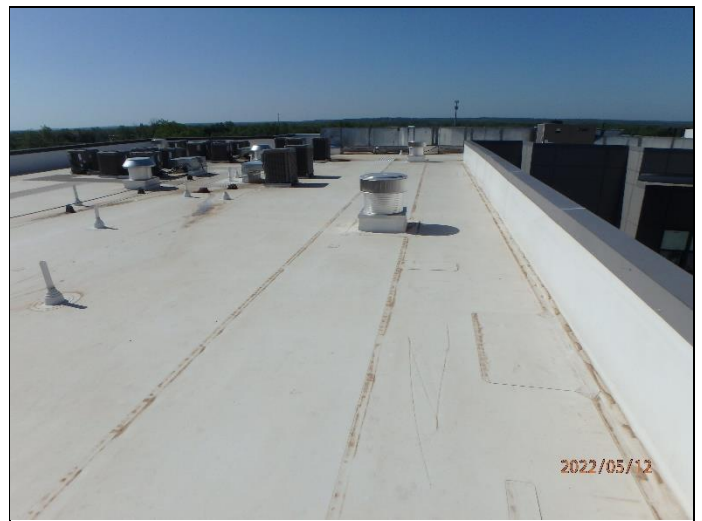
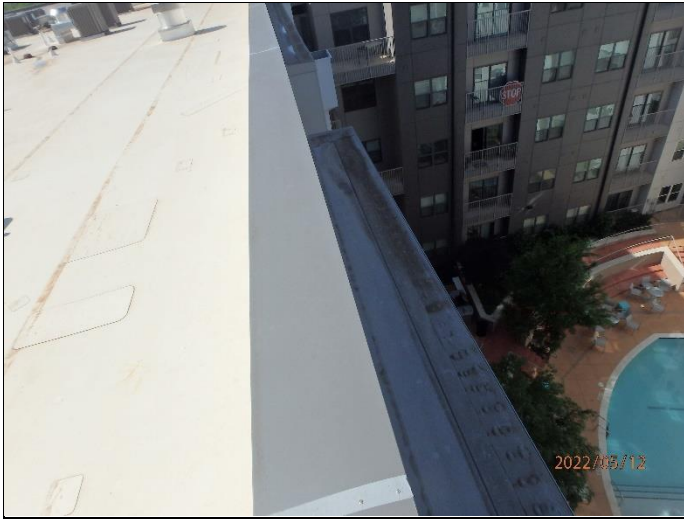
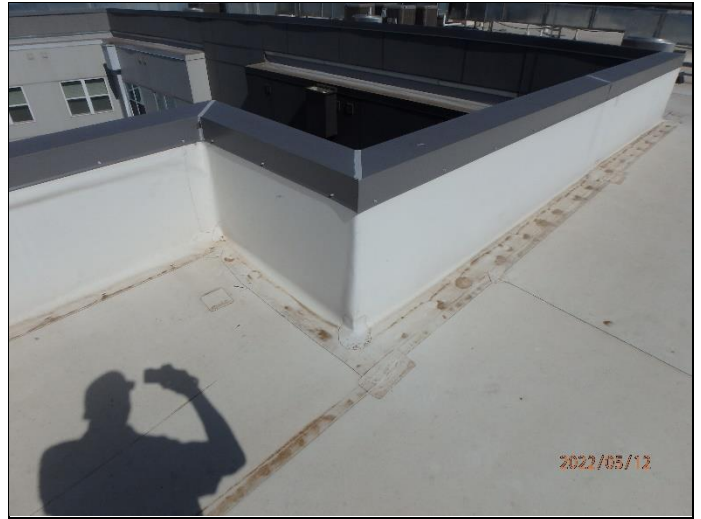
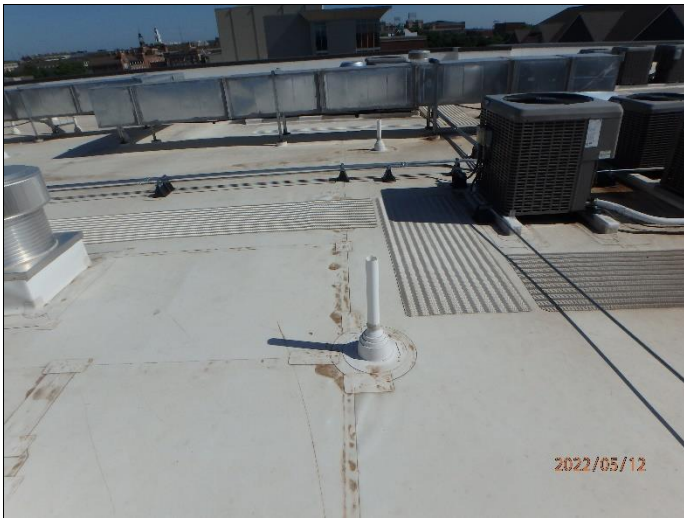
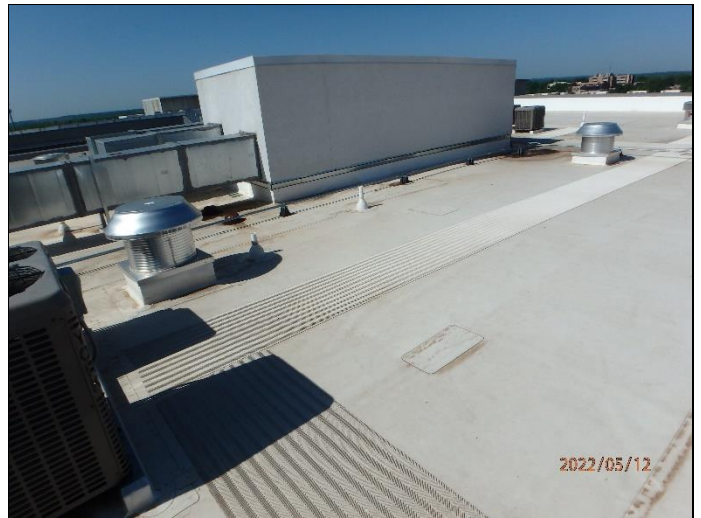
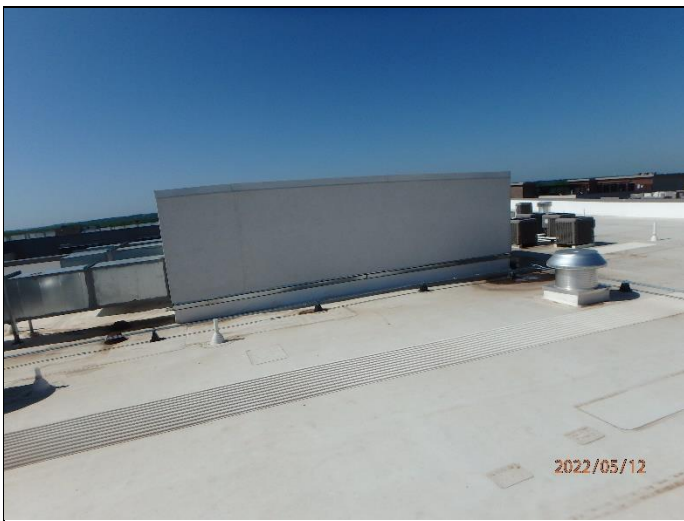
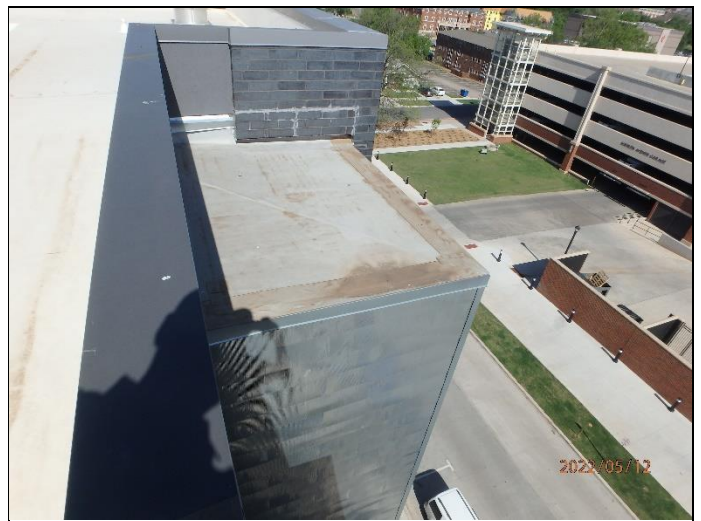
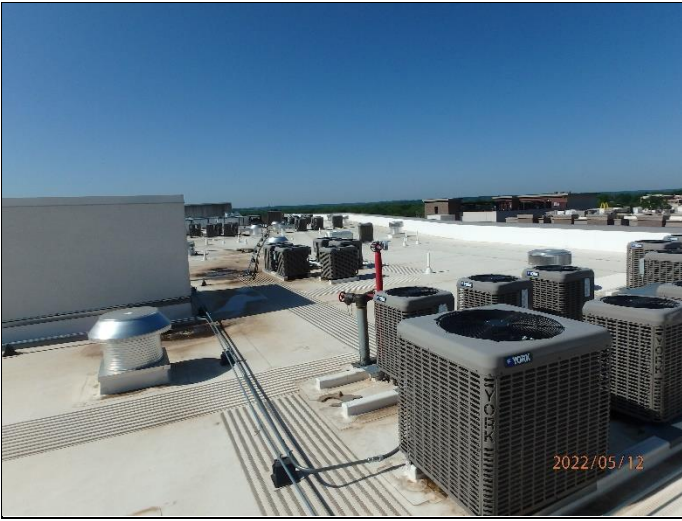
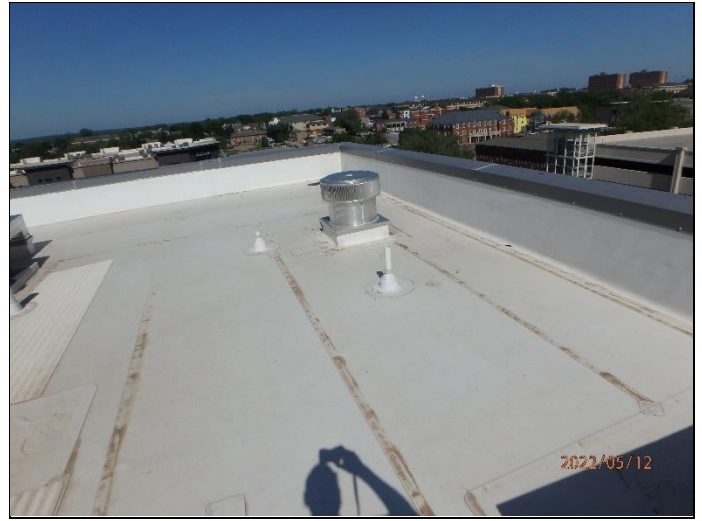
84. Overview of Courtyard 2 roof

85. Overview of Courtyard 2 roof

86. Overview of Courtyard 2 roof

87. Overview of Courtyard 2 roof

88. Overview of Courtyard 2 roof

89. Overview of Courtyard 2 roof

90. Overview of Courtyard 2 roof

91. Overview of Courtyard 2 roof

92. Overview of Courtyard 2 roof

93. Overview of Courtyard 2 roof

94. Overview of Courtyard 2 roof

95. Overview of Courtyard 2 roof

96. Overview of Courtyard 2 roof

97. Overview of Courtyard 2 roof

98. Overview of Courtyard 2 roof

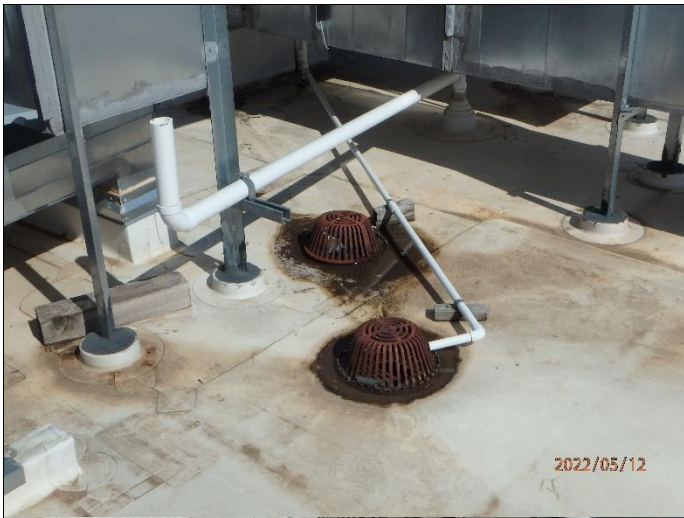
104. Primary and secondary drain – secondary drain is too high for drainage

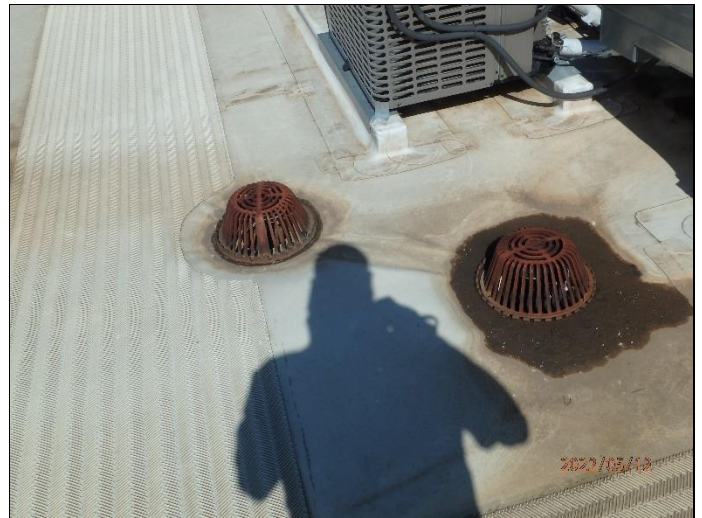
105. Primary and secondary drain – secondary drain is too high for drainage

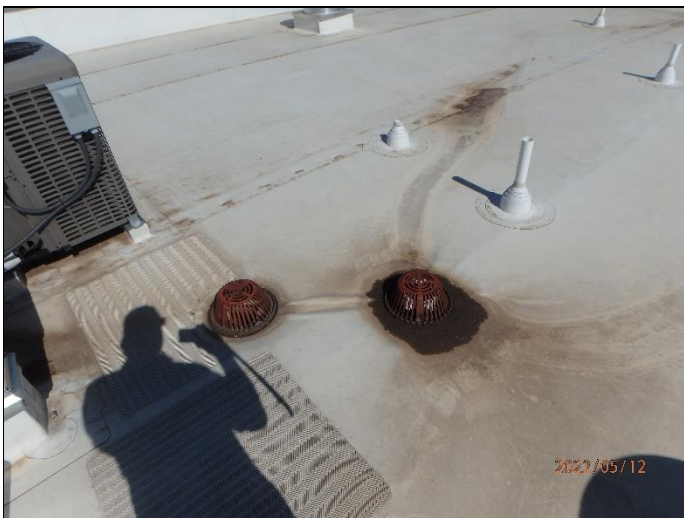
106. Primary and secondary drain – secondary drain is too high for drainage

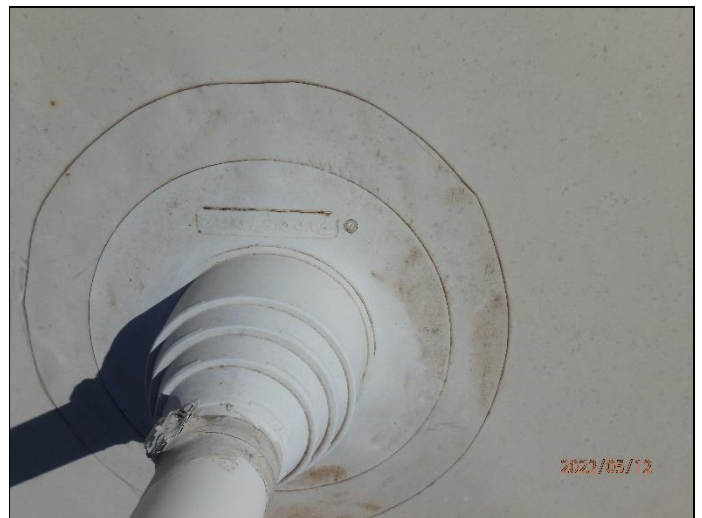
107. Primary and secondary drain – secondary drain is too high for drainage

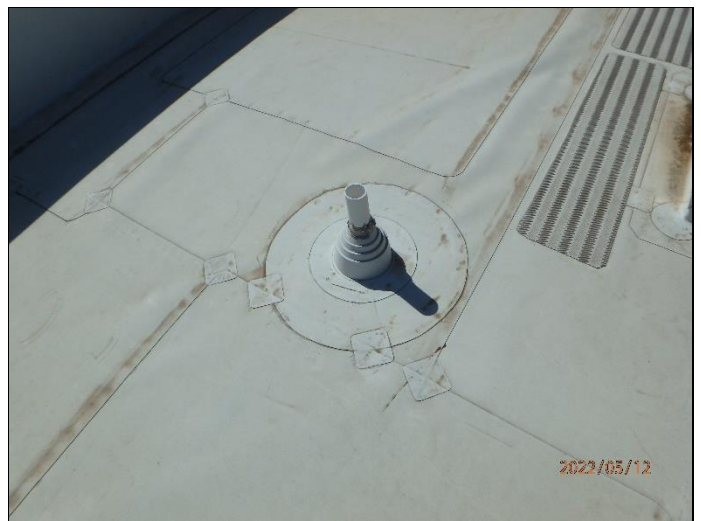
123. Primary and secondary drain – secondary drain is too high for drainage

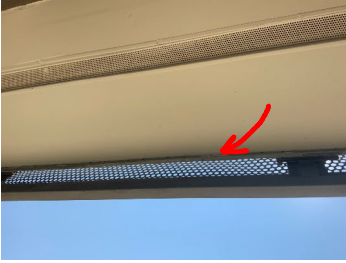
At soffit, the stucco weep channel is sealed

- 1.10 East Elevation – We noted balcony guardrail plates attached to stucco with screws that were under-driven and not sealed.
 - 1.11 East Elevation – We observed random soffit areas where the stucco weep channel was sealed. This does not allow the stucco to weep.

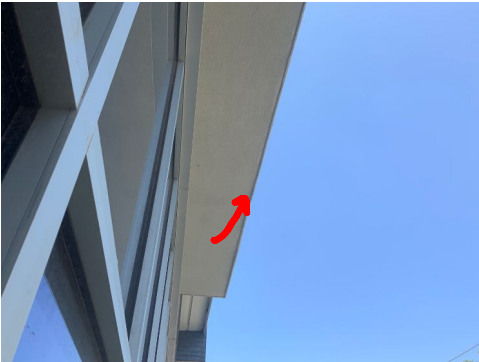
Drainage plane at soffit return sealed

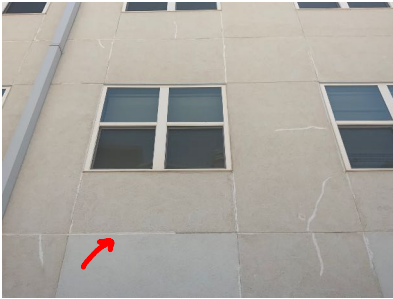
stucco CJs and EJs are filled w/ sealant. What is the intent?

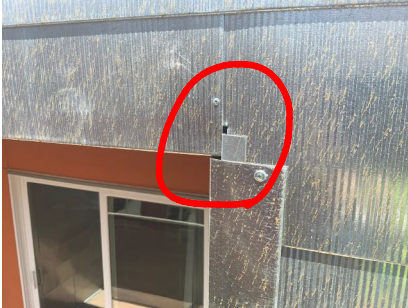
Corner trim unsealed

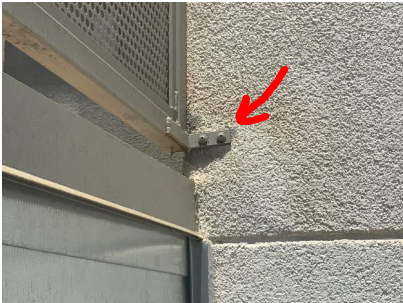
No sealant at guardrail penetrations

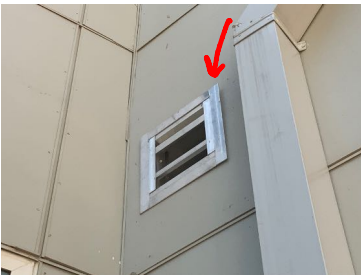
Several unsealed equipment penetrations

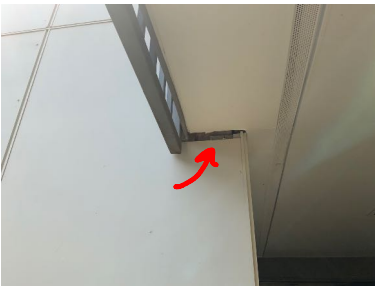
Large opening at soffit at # 328

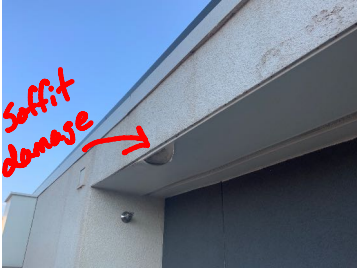
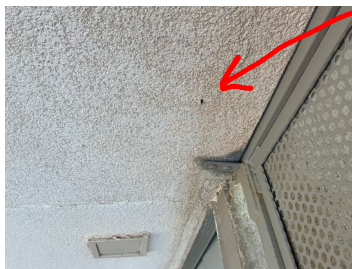
Unit 431 - Soffit lower than cladding. Also open tie-off penetrations

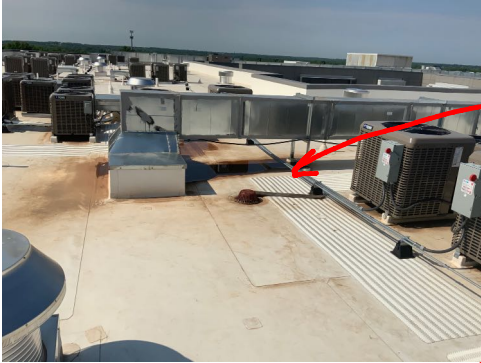
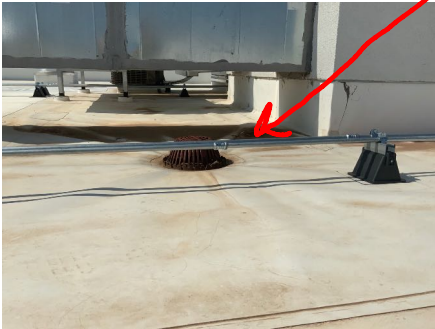
Primary drains exist, but do not see overflows.

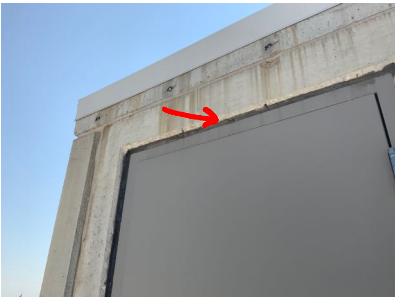
Mortar at stair door, instead of sealant

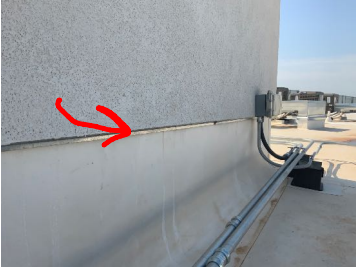
At stair penthouse, no receiver and counter-flashing.
Stucco attached through TPO

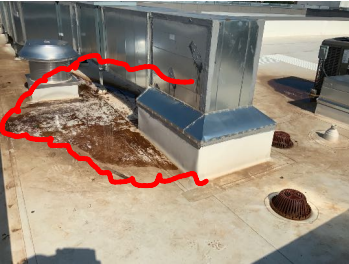
Water blocked from reaching the drains.

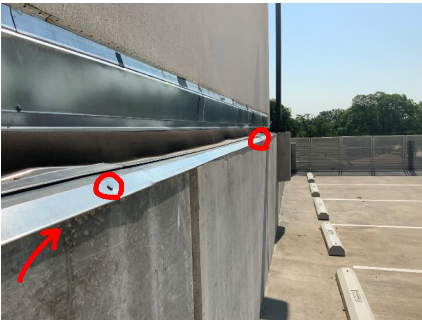
5K SECTION DETAIL @ ROOF AT PRECAST
SCALE: 1/2" = 1'-0"

EJ profile over concrete wall does not match the plans and fasteners are sparsely located. Also, some locations have negative slope.

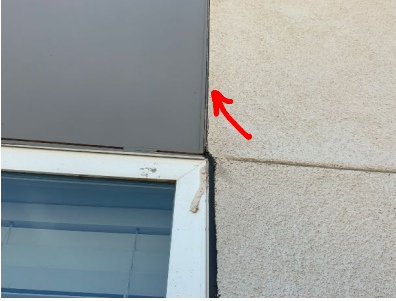
At the elevation directly above the lower roof, stucco has been terminated at cementitious panels w/ a control joint in lieu of a J-mold & is not sealed.

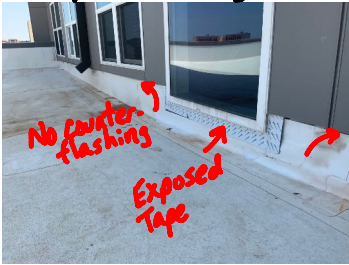
Similar area as above, there is exposed window flashing tape and no 2-piece flashing assembly at the cladding interface.

Also, Dupont tape is used, although Tamlyn is the WRB system to be used
